Sanitary Survey of Crooked Creek and Smith Hollow Creek

Task 4, Integrated Water Resources Management Plan Town of Colchester, Vermont

*Prepared for Aldrich + Elliott, PC by Bruce F. Douglas, PE, Brent Toth, and Katie Budreski
Project ID: 051694-G*

December 20, 2011

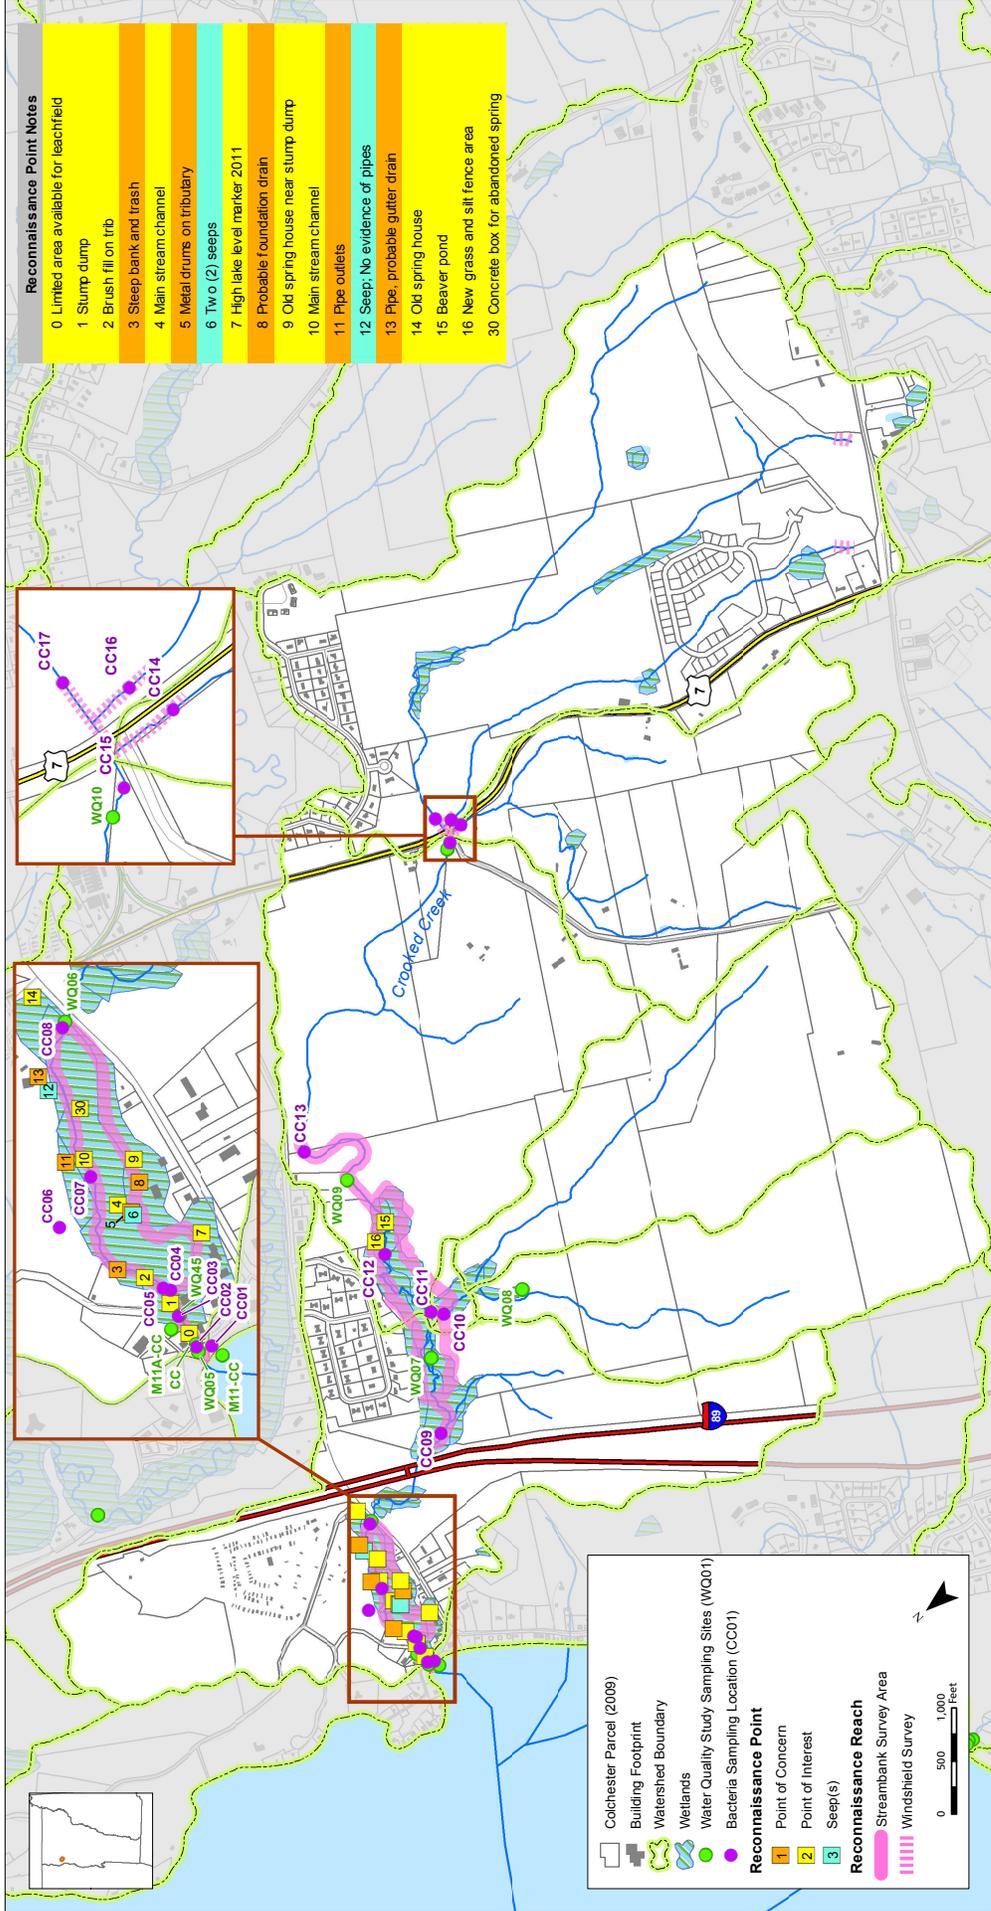
Figure 1. Crooked Creek – Field Reconnaissance and Bacteria Sampling Location (November 2011)
Town of Colchester, Vermont

The following is a summary of the streambank reconnaissance observations for Crooked Creek, as illustrated in Figure 1:

- One location with trash on steep bank (see #3).
- One location with metal drums on the streambank of a tributary stream (see #5).
- Three pipe outlets: one that appears to be a foundation drain (see #8), one that appears to be a gutter drain (#13), and, one that has no clear apparent source (see #11).

Sampling of 17 locations along Crooked Creek and its tributaries was completed on November 14, 2011 (Table 1, Figure 1). All of the results were below the state's water quality standard of 77 organisms per 100 mL for *E. coli*. In fact, all *E. coli* concentrations in these samples were less than 30 MPN/100 mL.

These low results contrast with previous sampling upstream of the outlet of the creek in August and October of 2010 (Aldrich + Elliott, 2011). Five samples were collected during those months at WQ-05, WQ-45, WQ-06, WQ-07, and WQ-08 (Figure 1). Among these five samples, there were three exceedances of the state water quality standard, at WQ-05, WQ-06, and WQ-07. MST analyses of these samples revealed human, wild bird, and wild animal sources at all three locations, along with a domestic animal (dog) source at WQ-07. The sharp contrast reveals the variability in fecal indicator bacteria concentrations over time. No obvious potential sources of human bacterial contamination were observed during the sanitary survey of Crooked Creek.

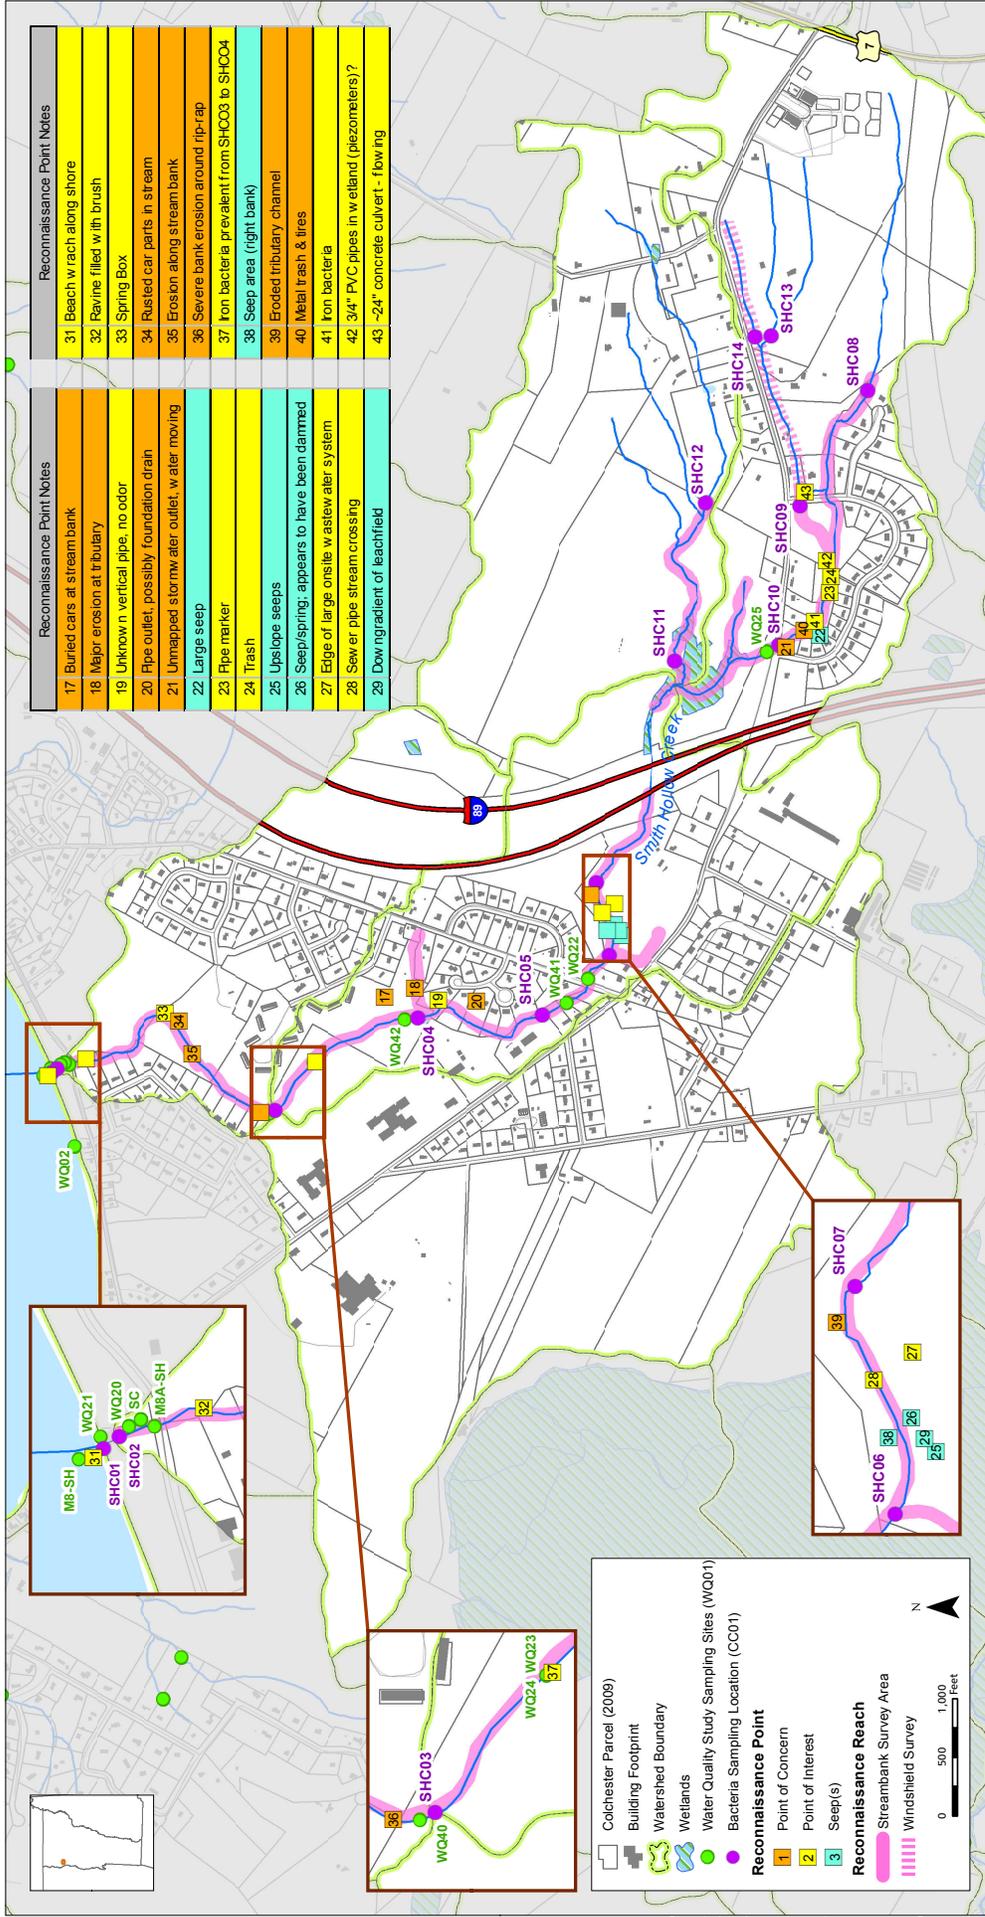
Figure 2. Smith Hollow Creek – Field Reconnaissance and Bacteria Sampling Location (November 2011)
Town of Colchester, Vermont

The following are the highlights of the streambank reconnaissance observations for Smith Hollow Creek, as illustrated in Figure 2:

- Four locations of severe streambank erosion (see #18, #35, #36, #39).

- Three locations of buried cars, automobile parts, or metal and trash along the creek (see #17, #34, #40).
- A seep area, noted by three adjacent seeps, that appears to be downgradient of a cluster leachfield serving a portion of the Everbreeze Drive subdivision (see #25, #26, #29).
- One pipe outlet that appears to be a foundation drain (see #20).

Sampling of 14 locations along Smith Hollow Creek and its tributaries was completed on November 10, 2011. Of the 14 analyses, only one location had an exceedance of the *E. coli* water quality standard. The exceedance was at SHC-05, located downstream of Williams Road. The *E. coli* concentration at this location was 210 MPN/100 mL. The *E. coli* concentration at the sampling point immediately upstream of Williams Road was 9 MPN/100 mL. There is no apparent evidence between these locations as to whether the exceedances at SHC-05 was attributable to wildlife, pets/domestic animals, or a human source; therefore, further interpretation of this result is not possible.

One of these previous exceedances was located immediately upstream from Williams Road, at location WQ-22 (Figure 2). The *E. coli* concentration for this sample was 84 MPN/100 ml, and was not analyzed (ribotyped) for source species. The other upstream exceedance in 2010 was WQ-25, immediately downstream of Blakely Road (Figure 2). The WQ-25 sample was ribotyped and revealed three identified sources: goose, deer, and sheep.

Although no definitive conclusions can be drawn from these limited data, there is a possibility that the exceedences at WQ-22 and SHC-05 may be related to the seeps on the left bank of Smith Hollow Creek upstream of WQ-22, which appear to be downgradient of the cluster leachfield serving the Everbreeze Drive subdivision.
