4. ASSESSMENT FINDINGS

4.1. Inner Mallets Bay

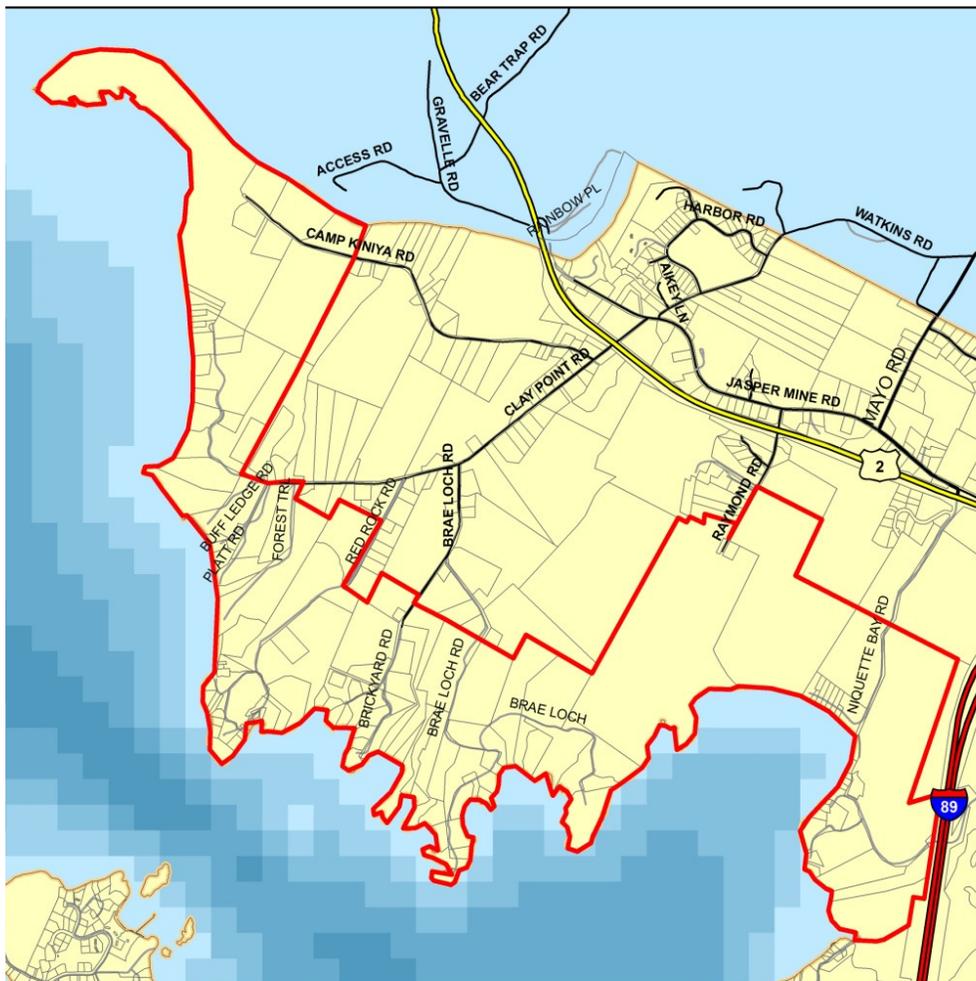
North Mallets Bay/Niquette Bay Study Area

North Mallets Bay/Niquette Bay is an area of land with one hundred nine (109) developed properties located in inner Mallets Bay bordered by US Route 2 to the north, Interstate 89 to the east and Lake Champlain to the west and south. The area consists of a mix of year-round residences and seasonal camps. Detailed wastewater assessments were performed in this area on November 3 and 10, 2010 and September 13, 2011.

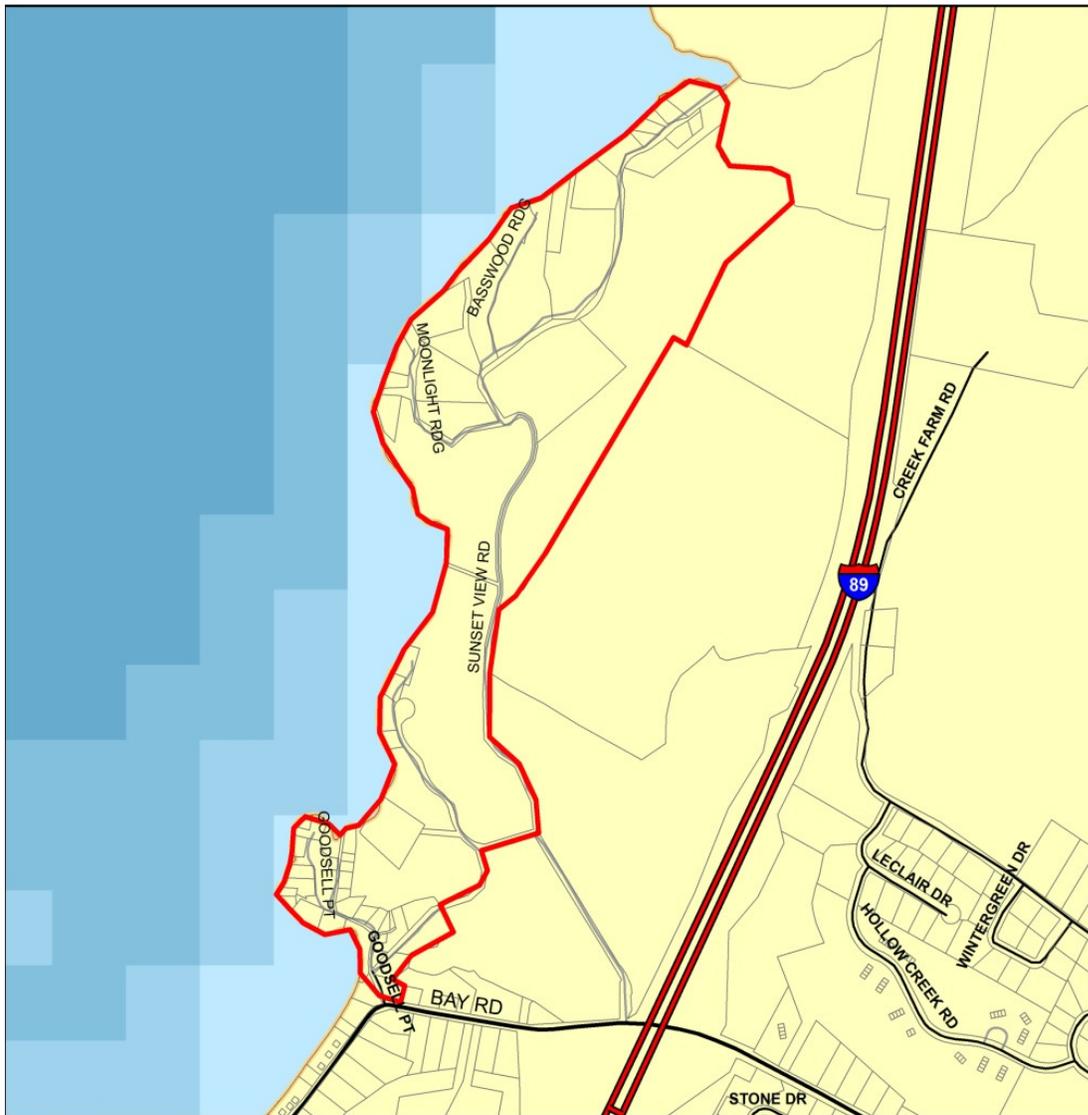
Goodsell Point/Sunset View Road Study Area

Goodsell Point and Sunset View Road is an area with forty-nine (49) developed properties located in inner Mallets Bay bound to the east by Interstate 89, west by Lake Champlain, south by Bay Road and north by Indian Brook inlet. The area consists of a mix of seasonal camps and year-round residential properties. Detailed wastewater assessments were performed in this area on September 21, 23, and 24 and November 3, 2010.

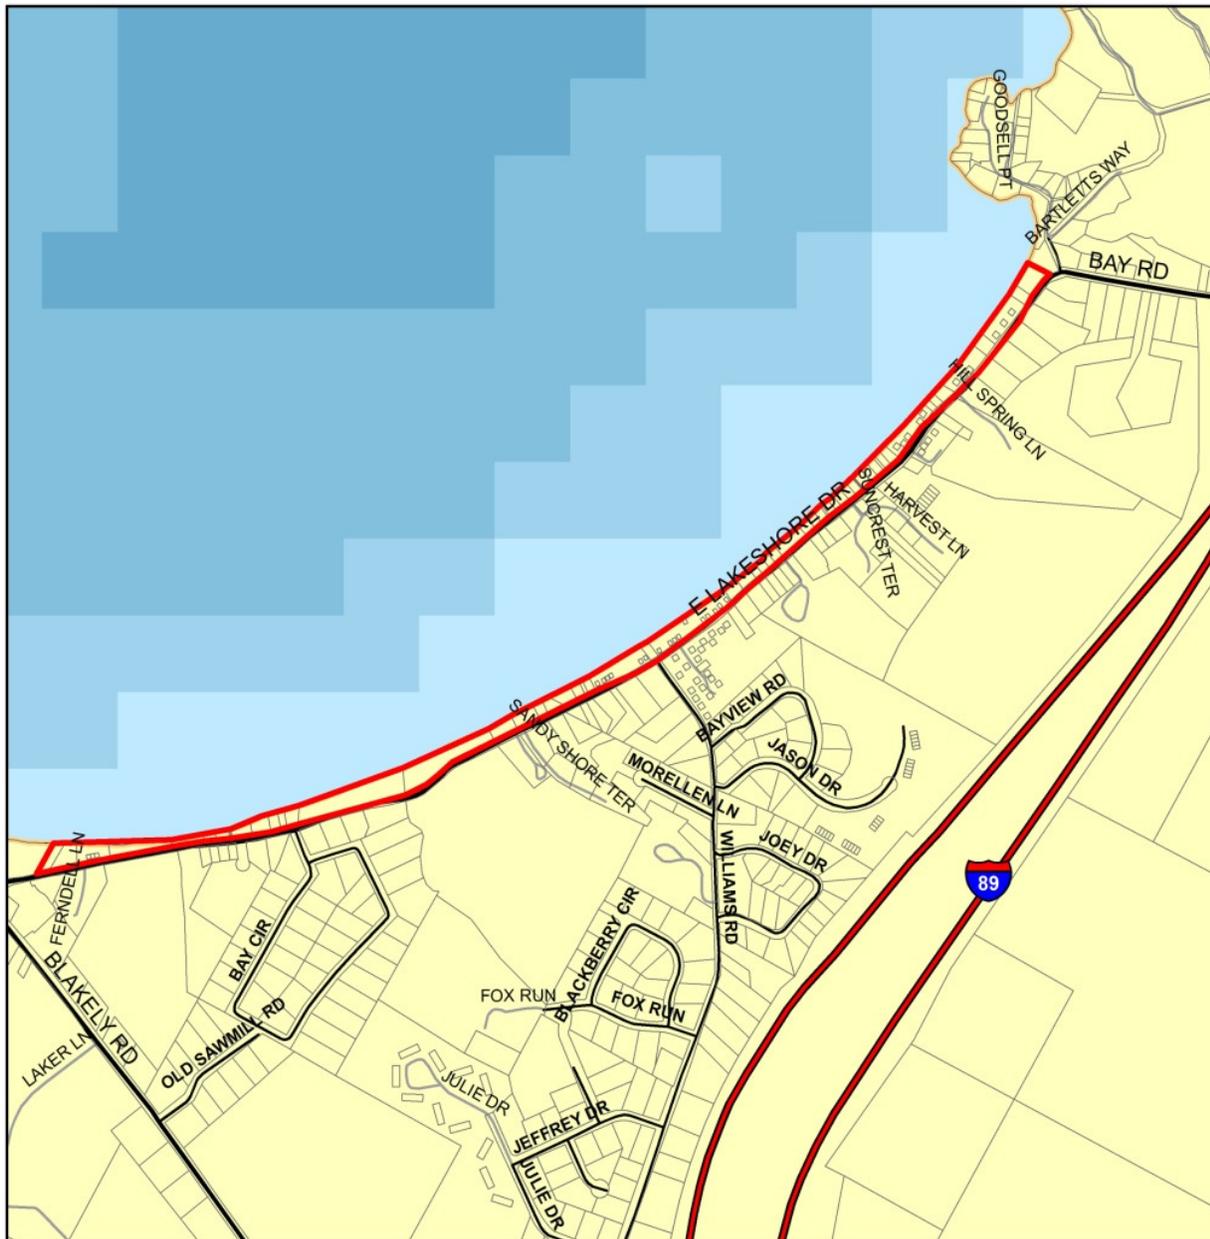
East Lake Shore Drive West (lakeside) Study Area

East Lakeshore Drive West (lakeside) is an area with sixty-two (62) developed properties in inner Mallets Bay bound to the west by Lake Champlain, south by Blakely Road & West Lakeshore Drive, north by Bay Road and east by East Lakeshore Drive. The area consists primarily of seasonal camps with a few year-round residences. Detailed wastewater assessments were performed on September 21, 23, 24, and 29, 2010, October 7 and 13, 2010 and September 9, 2011.

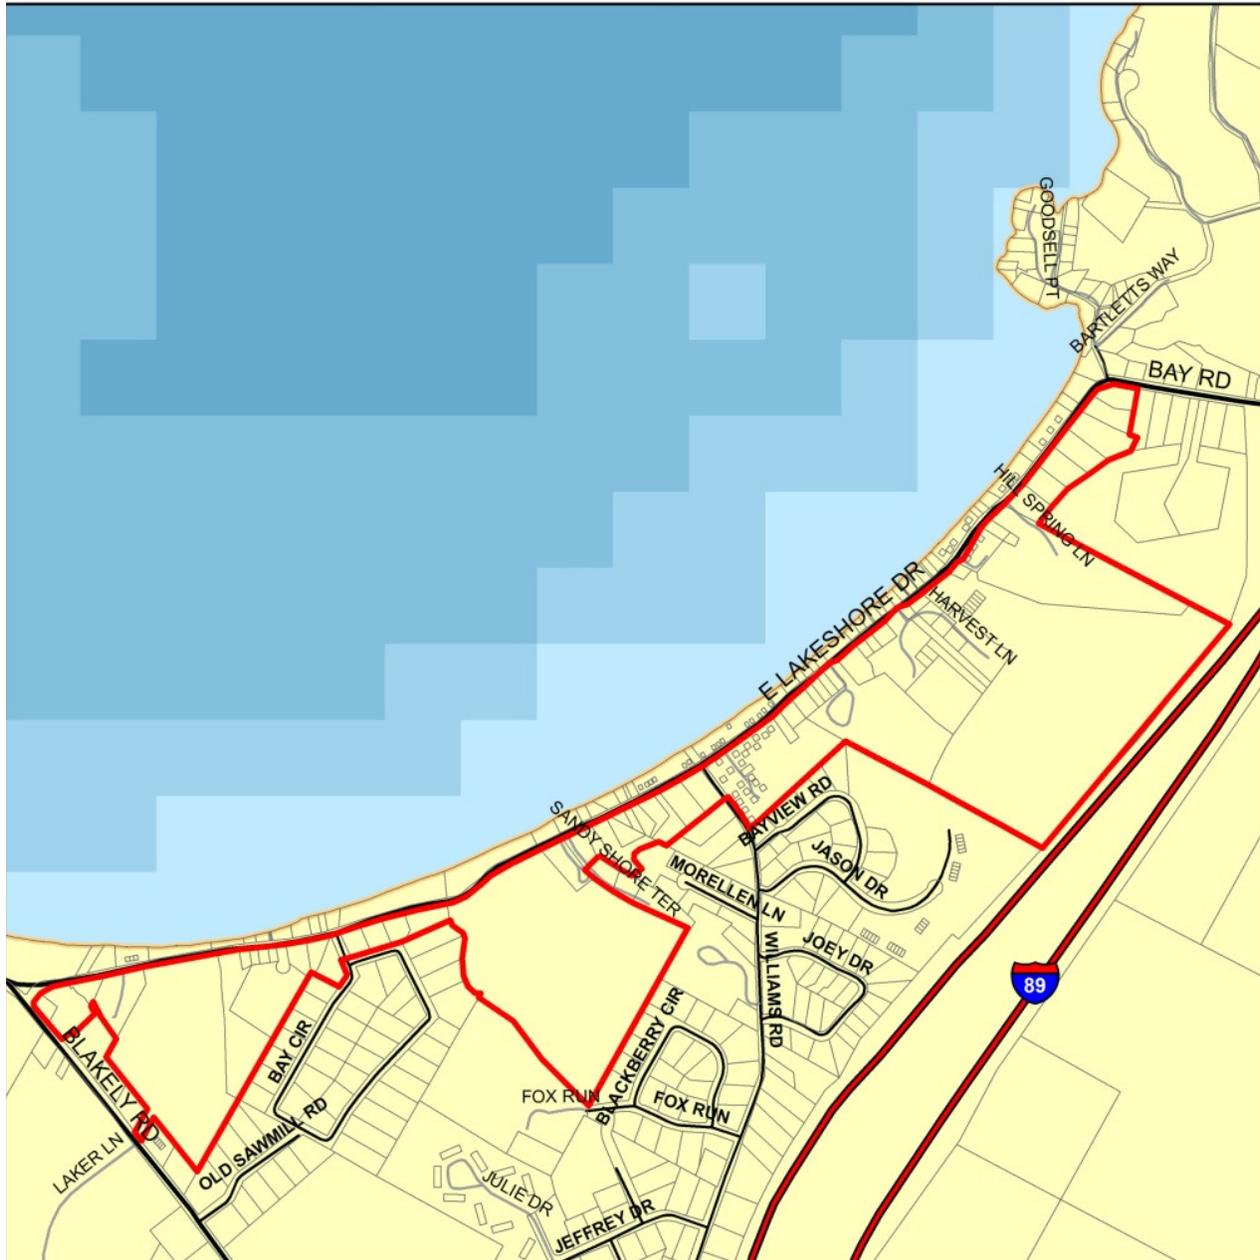
East Lake Shore Drive East (road side) Study Area

East Lakeshore Drive East (roadside) is an area of ninety-four (94) developed properties in inner Mallets Bay bound to the east by Interstate 89, west by East Lakeshore Drive, south by Blakely Road and West Lakeshore Drive, and north by Indian Brook inlet. The area consists primarily of year-round residential properties. Detailed wastewater assessments were performed in this area on September 21, 23, 24, and 29, 2010, October 7 and 13, 2010 and September 9, 2011.

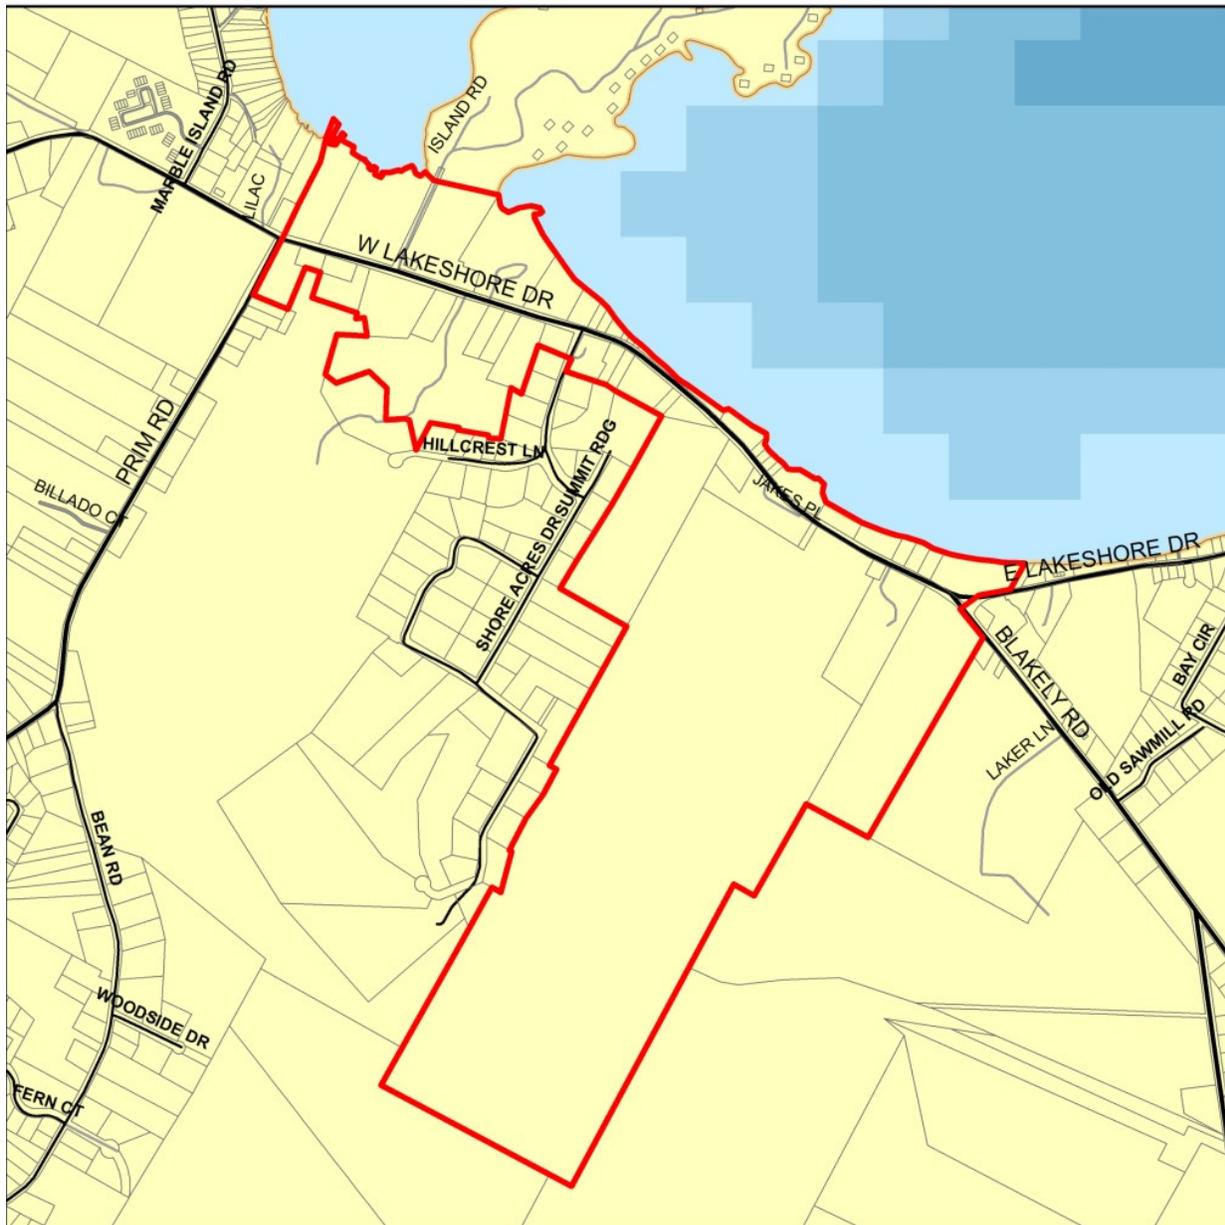
West Lake Shore Drive Study Area

West Lakeshore Drive is a stretch of land with forty-three (43) developed properties located in inner Mallets Bay bound to the east by East Lakeshore Drive and Blakely Road, west by Holy Cross Road, south by Shore Acres and north by Lake Champlain. The area consists of mixed uses of year-round residential, seasonal residential, municipal recreation facilities, commercial, and industrial properties. Detailed wastewater assessments were performed on October 5, 6, 7, and 13, 2010, and September 9, 2011.

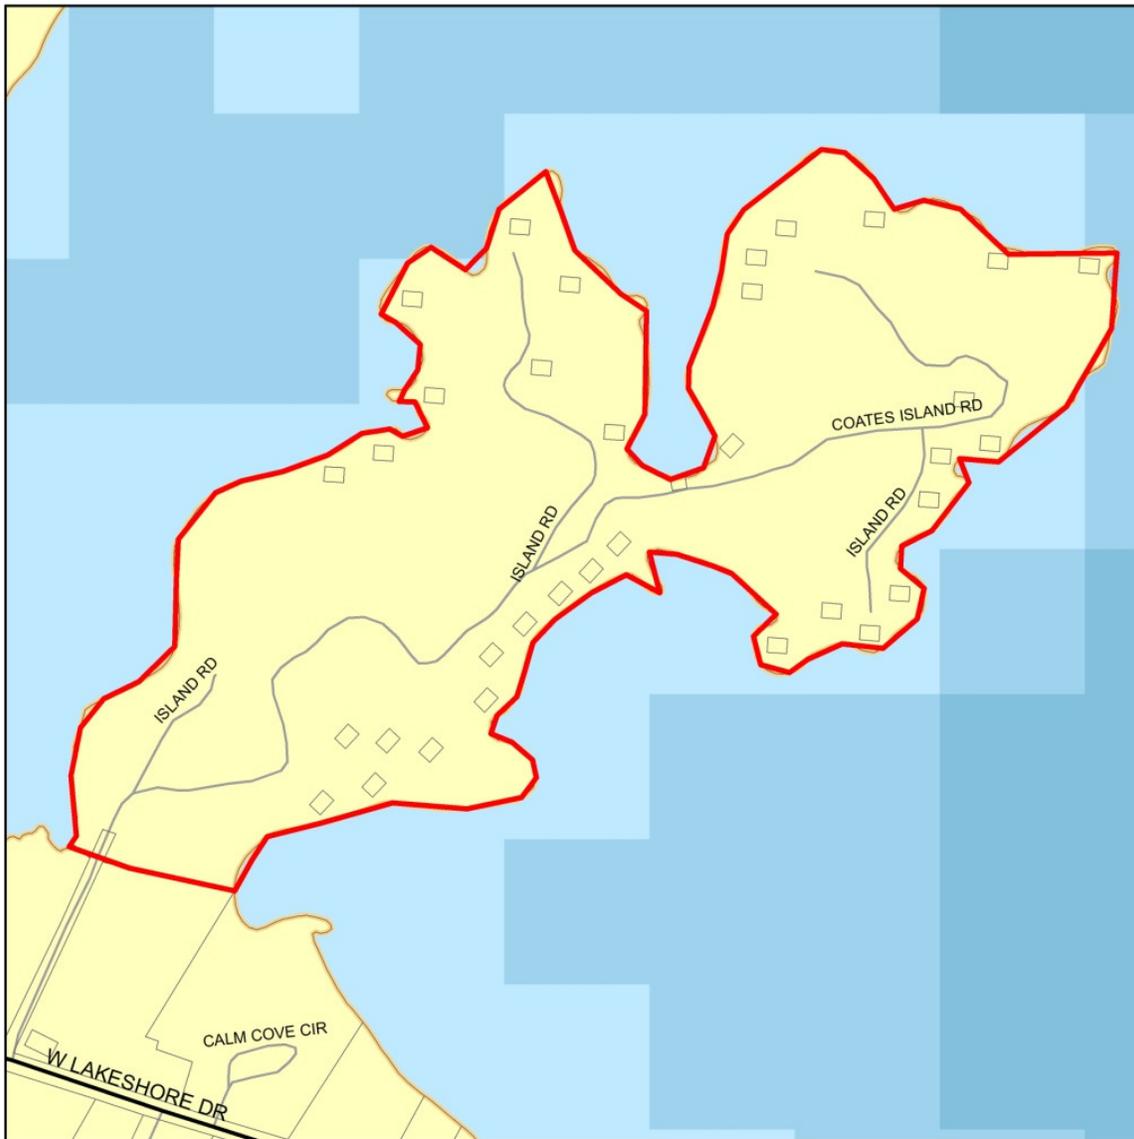
Coates Island Study Area

Coates Island is a peninsula with twenty-six (26) dwellings located in inner Mallets Bay with access from West Lakeshore Drive. The area consists mostly of seasonal camps; but there are three (3) year-round residences. Detailed wastewater assessments were performed in this area on October 14, 2010.

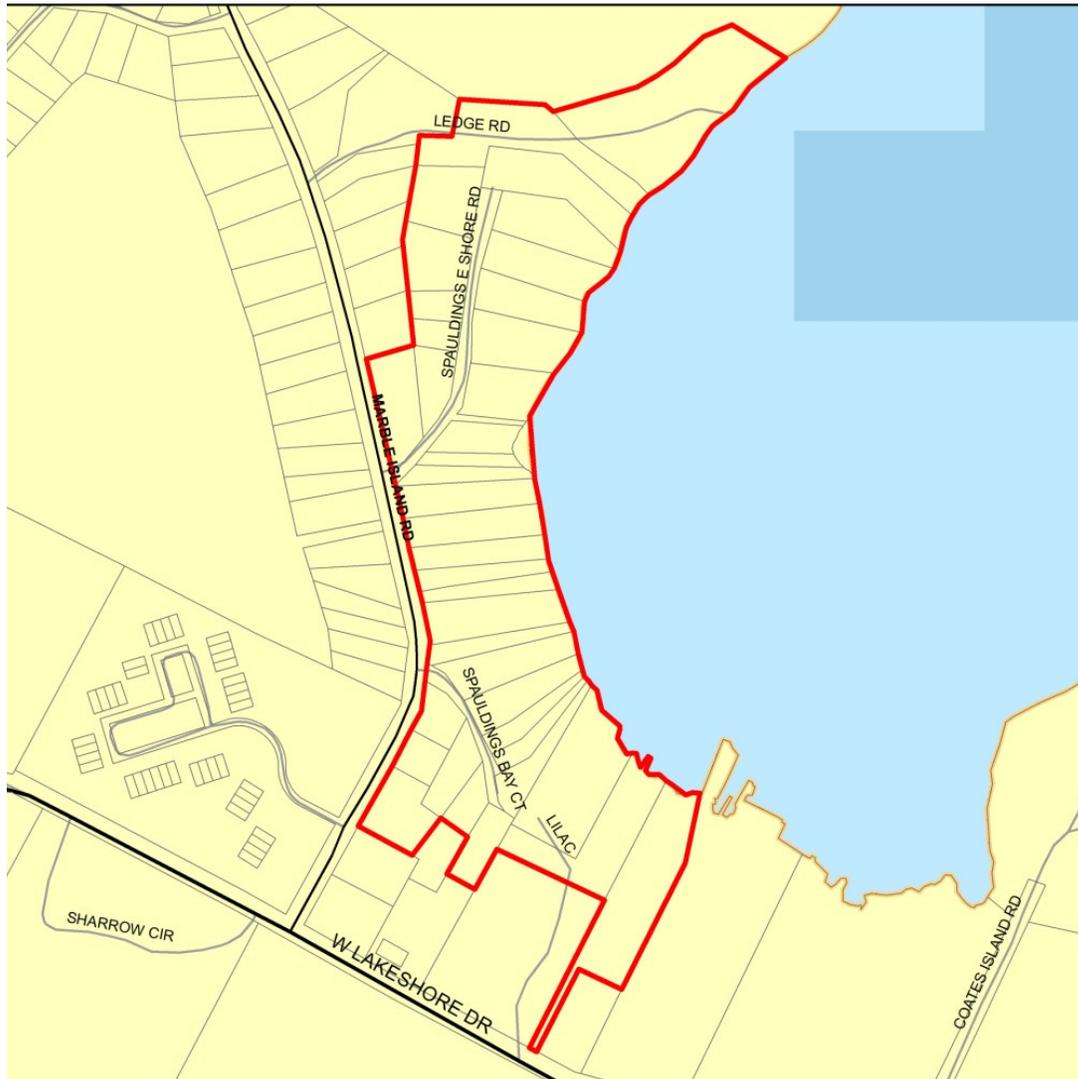
Spaulding East Shore Study Area

Spaulding East Shore is a portion of land with thirty-seven (37) developed properties located in inner Mallets Bay bound to the west and north by Marble Island, south by West Lakeshore Drive and east by Lake Champlain. The area consists of a mix of year-round residences and seasonal camps. Detailed wastewater assessments were performed in this area on October 13, 14, and 20, 2010.

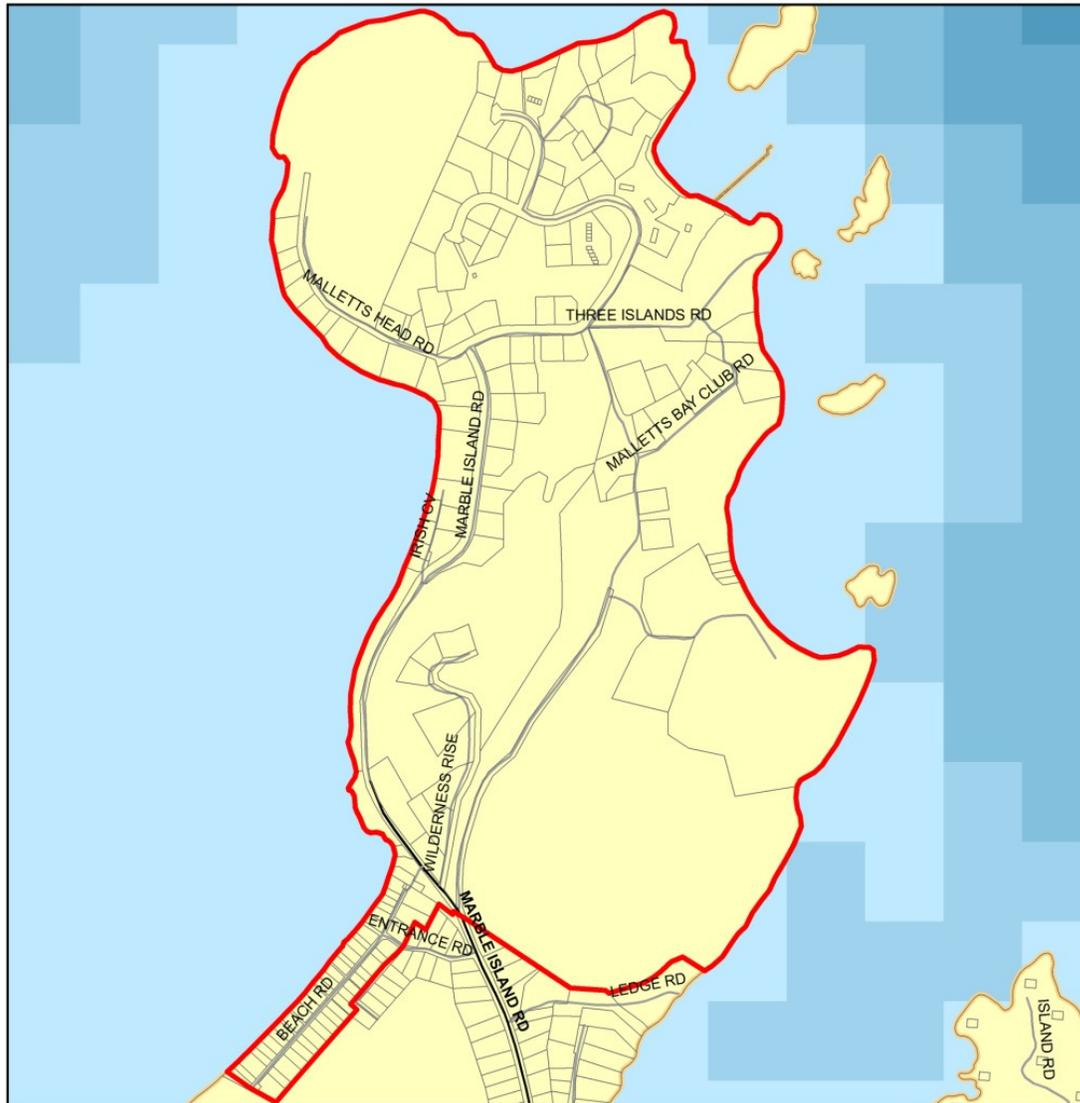
Beach Road/Marble Island Study Area

Beach Road/Marble Island is a stretch of land with one hundred fifty-six (156) developed properties located in outer Mallets Bay bordered by Thayer Beach and Spaulding East Shore to the east and south. Beach Road consists entirely of seasonal camps. Marble Island consists of a mixture of seasonal camps and year-round residences. Detailed wastewater assessments were performed in this area on September 17, 2010 and October 20, 2010.

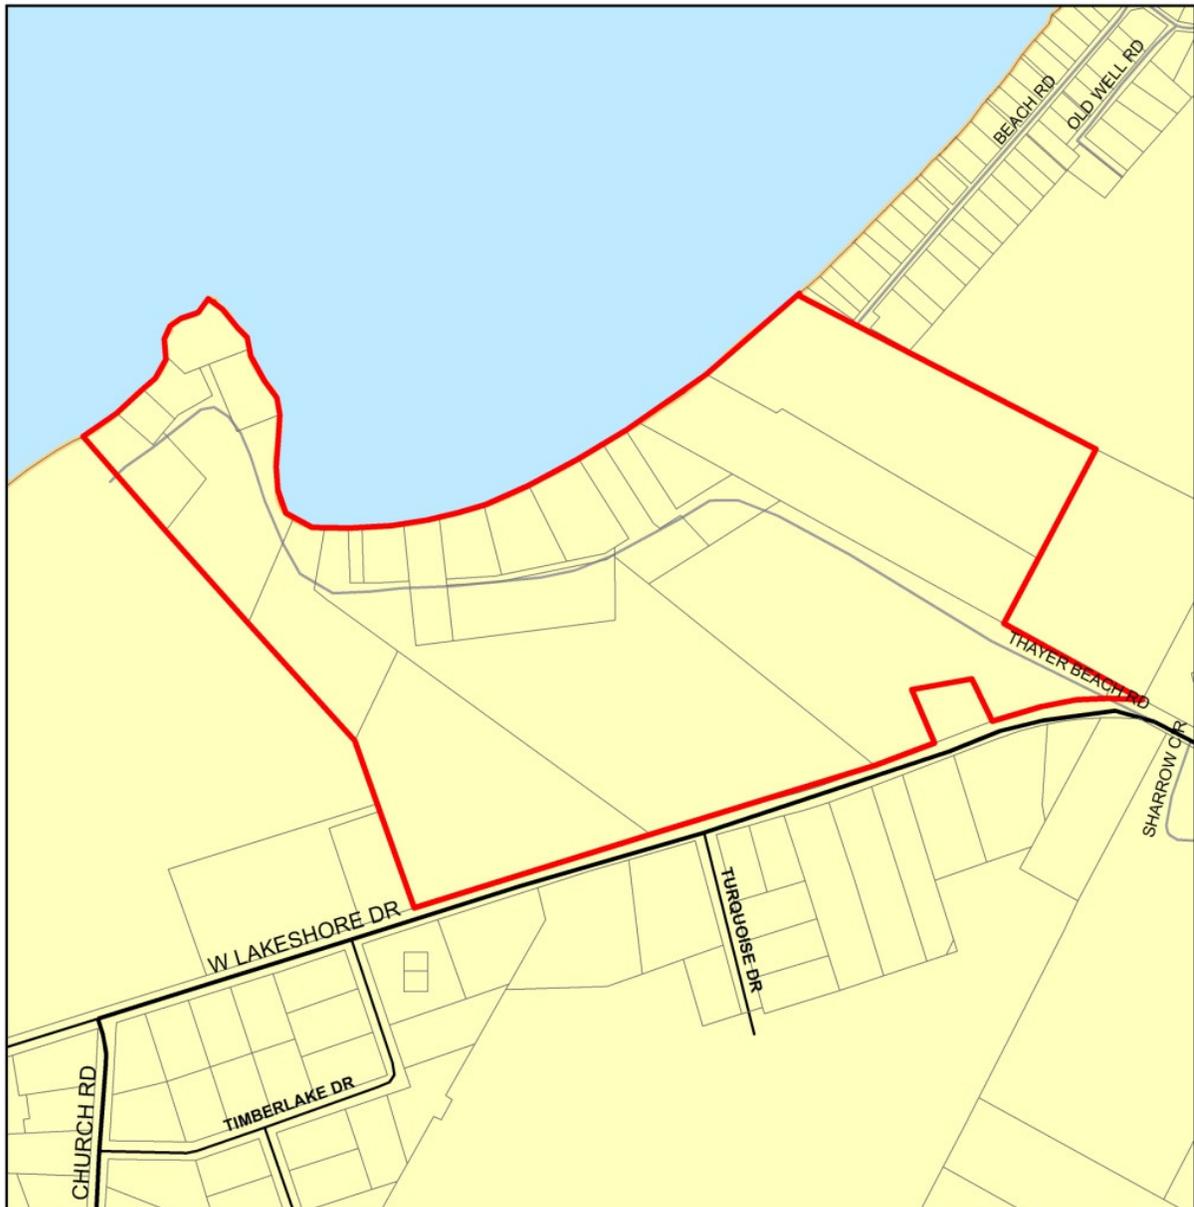
Thayer Beach Study Area

Thayer Beach is a stretch of land with eighteen (18) properties located in outer Mallets Bay bordered by Marble Island to the east, Holy Cross to the west, West Lakeshore Drive to the south and Lake Champlain to the north. The area consists of a mix of year-round residences and seasonal camps. Detailed wastewater assessments were performed in this area on October 10, 2010.

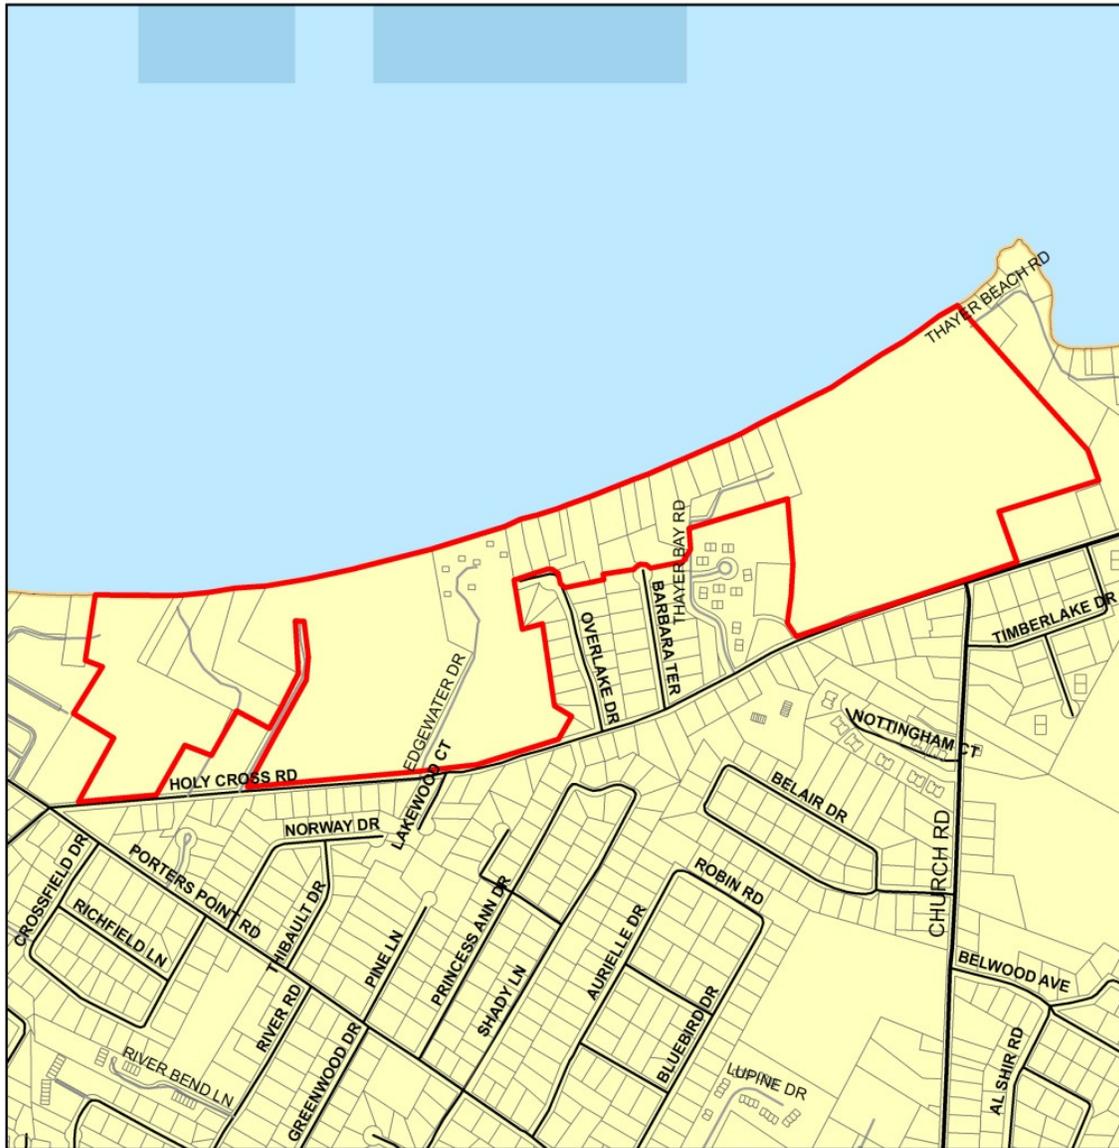
Holy Cross Study Area

Holy Cross is a stretch of land with twenty-five (25) developed properties on Holy Cross Road located in outer Mallets Bay with access at the intersection of Porters Point Road and Prim Road. The area consists of a mix of year-round residences and seasonal camps. Detailed wastewater assessments were performed in this area on October 21 and 22, 2010.

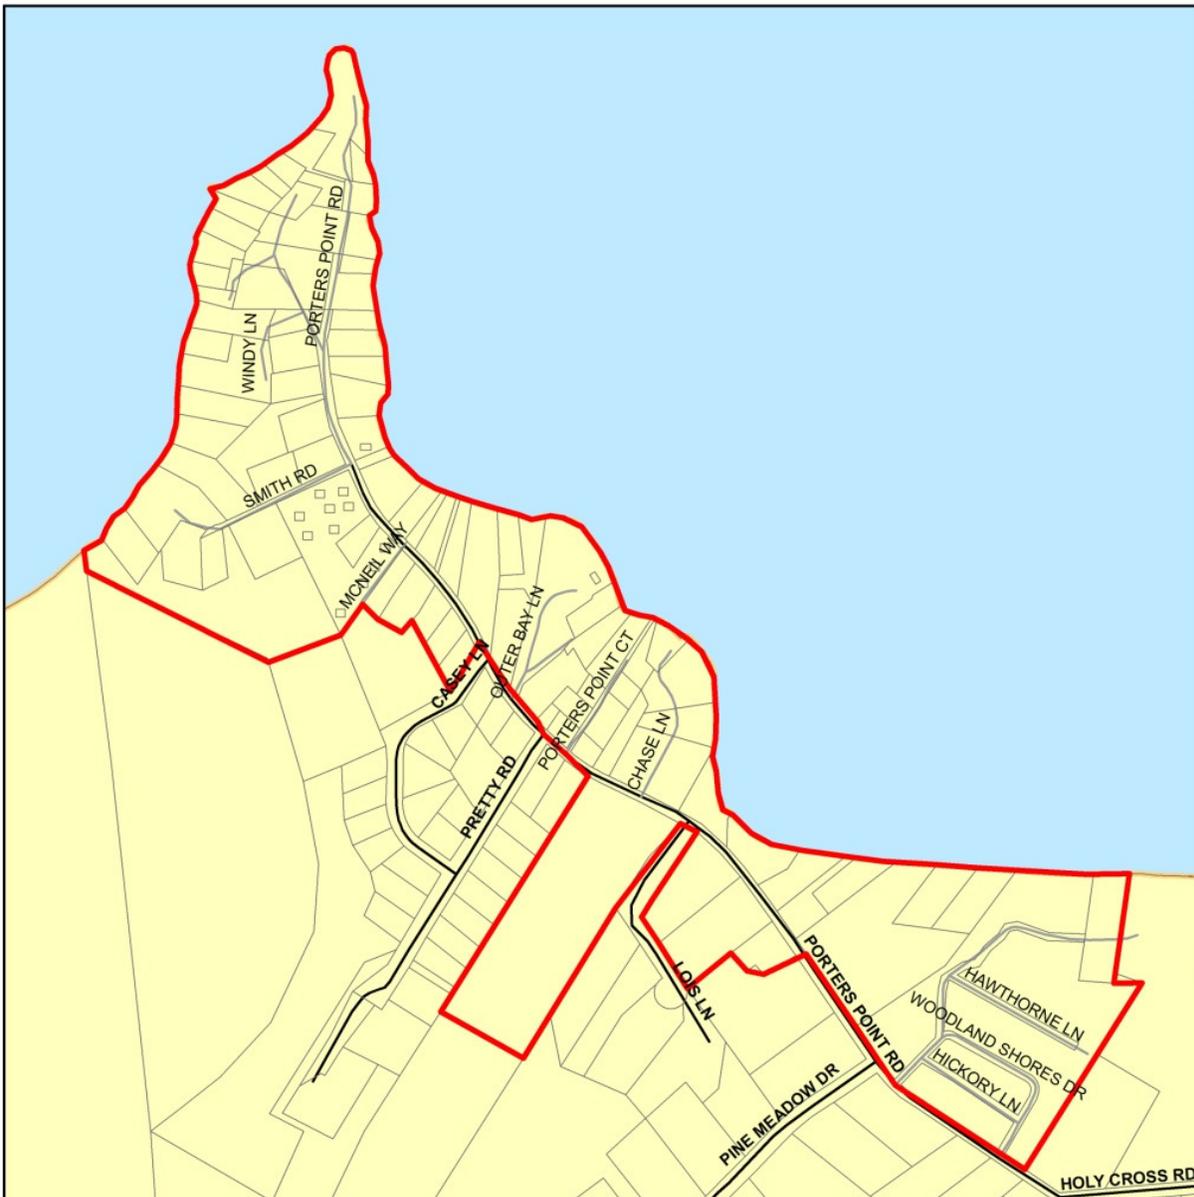
Porters Point Study Area

Porters Point is a point of land with ninety-two (92) developed properties located in outer Mallets Bay with access at the intersection of Holy Cross Road and Airport Road. The area consists of a mix of year-round residences and seasonal camps. Most existing wastewater systems are in-ground. Detailed wastewater assessments were performed on October 22, 2010 and September 8, 2011.

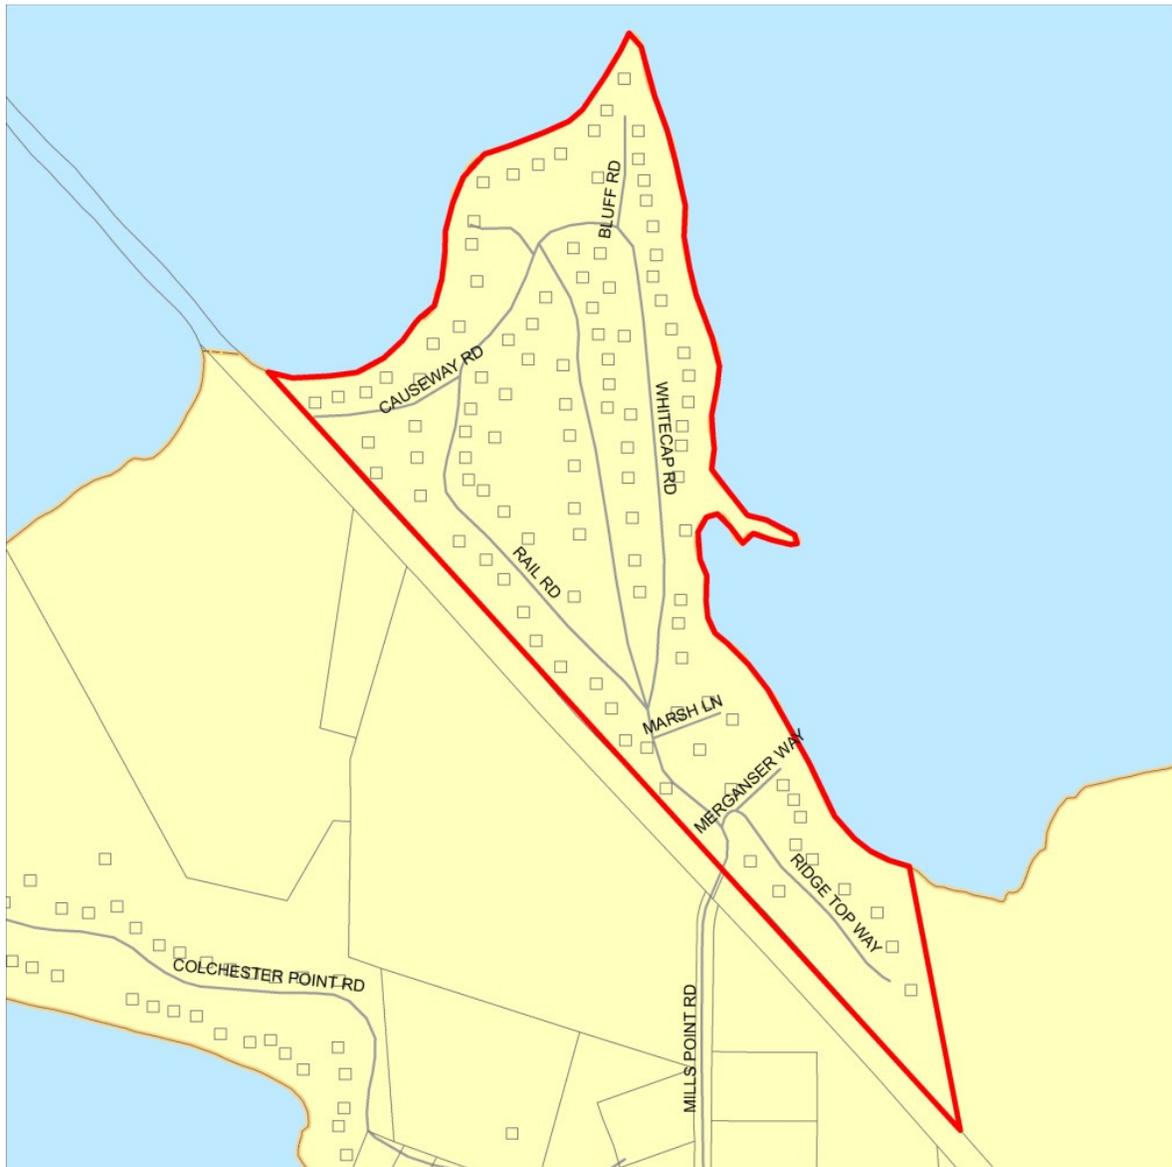
Mills Point Study Area

Mills Point is a point of land with one hundred four (104) dwellings located in outer Mallets Bay with access from Airport Road. The area consists of a mix of year-round residences and seasonal camps. Detailed wastewater assessments were performed in this area on October 26, 28, and 29, 2010 and September 8, 2011.

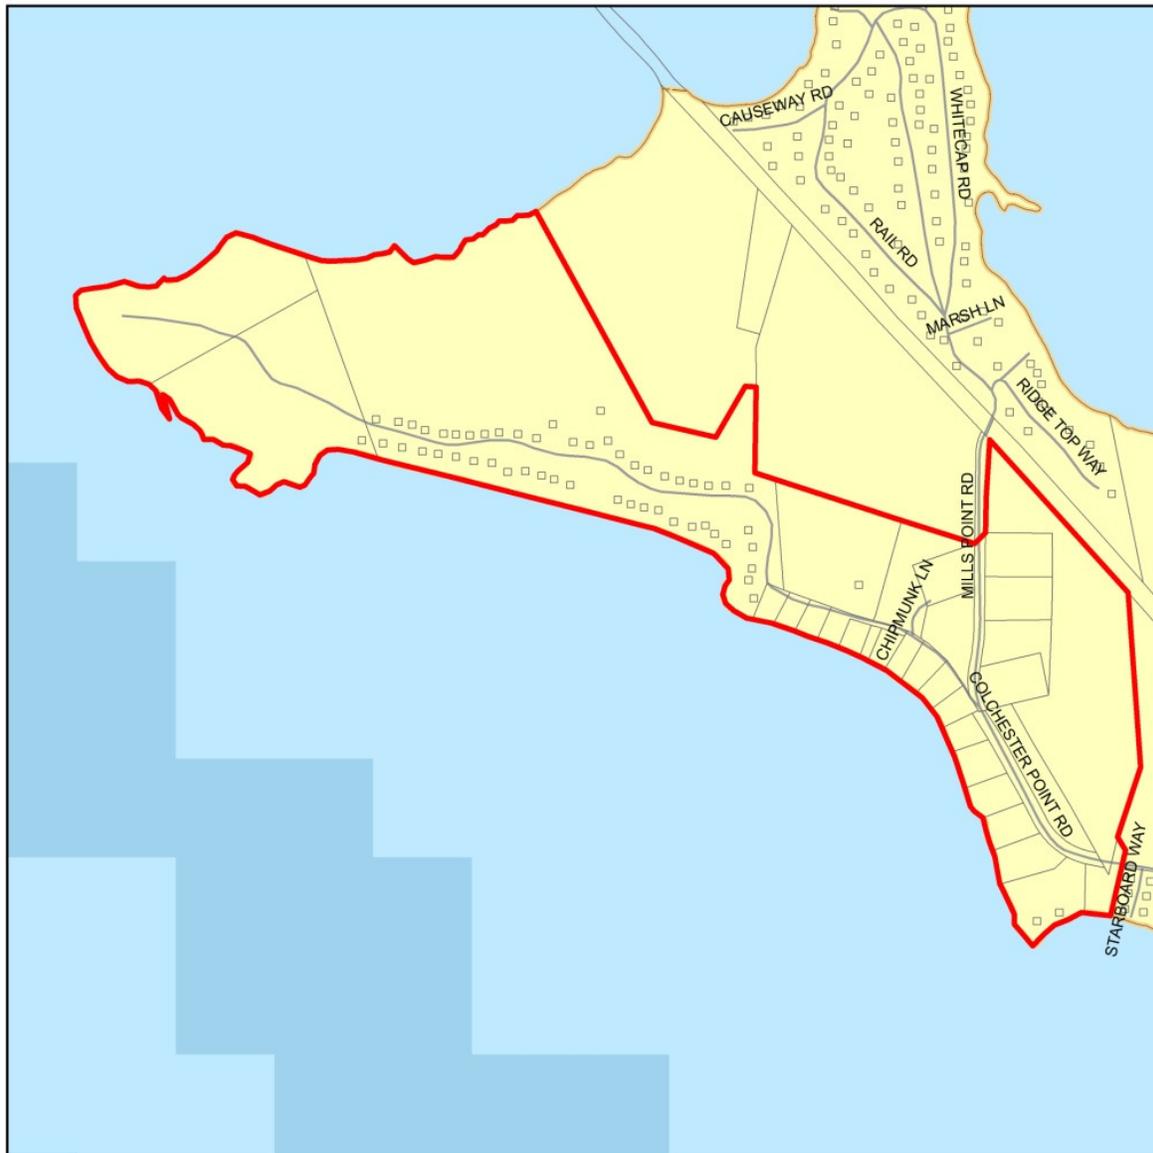
Colchester Point Study Area

Colchester Point is a stretch of land with eighty-one (81) developed properties located along Lake Champlain with access at the intersection of Airport Road and Mills Point Road. The area consists of a mix of seasonal and year-round residences. Detailed wastewater assessments were performed in this area on October 28, 2010.

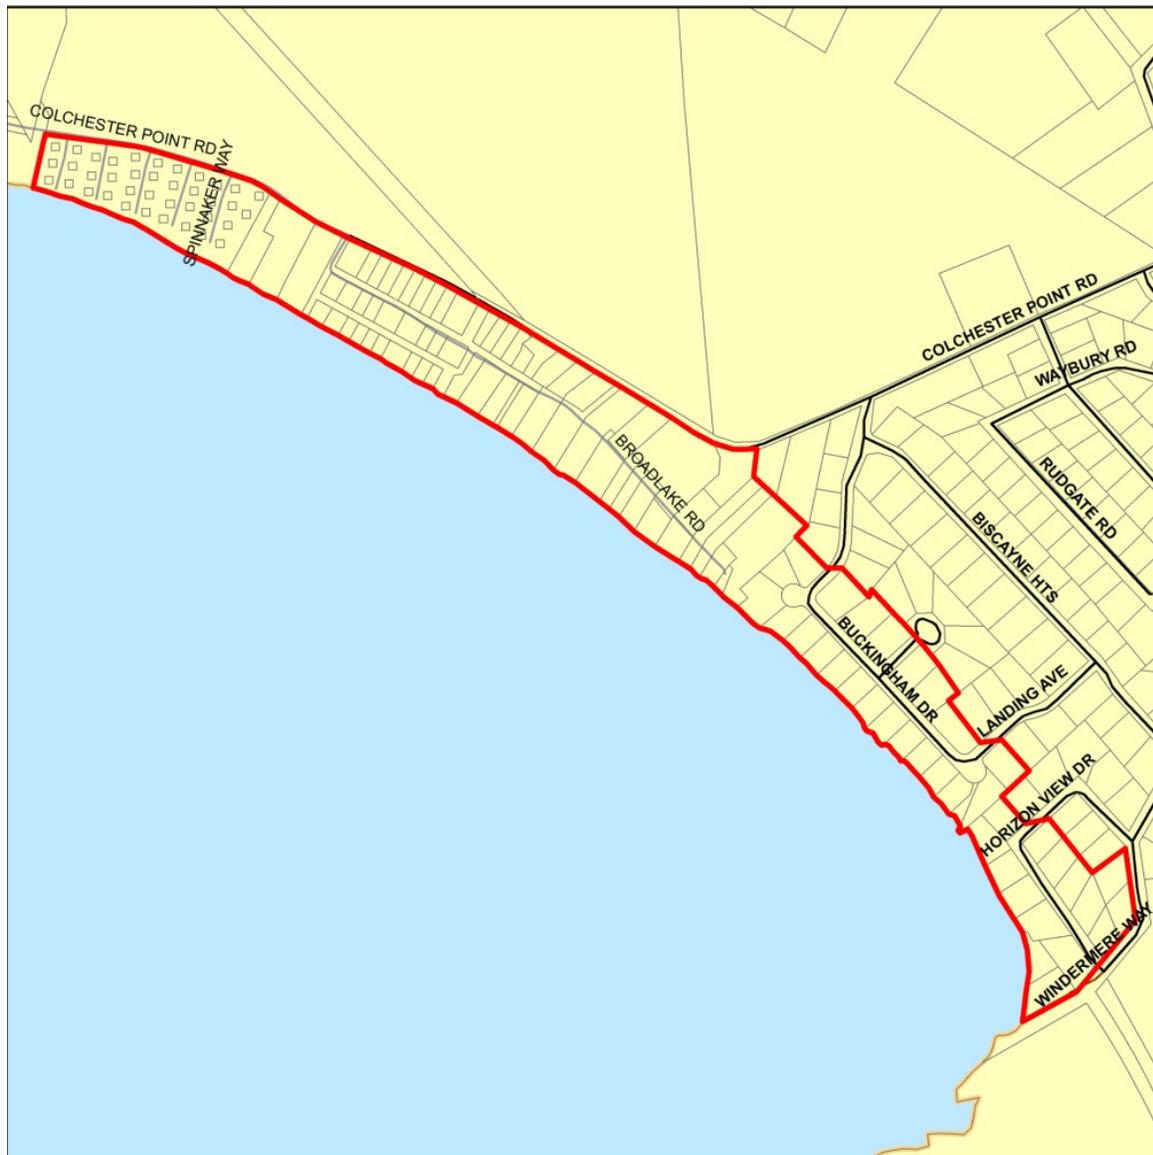
Broad Lake Shore Study Area

Broad Lake Shore is a stretch of land with one hundred twenty-three (123) developed properties located along Lake Champlain adjacent to Colchester Point. The area consists of a mix of seasonal and year-round residences. Detailed wastewater assessments were performed on October 28 and 29, 2010 and September 8 and 20, 2011.

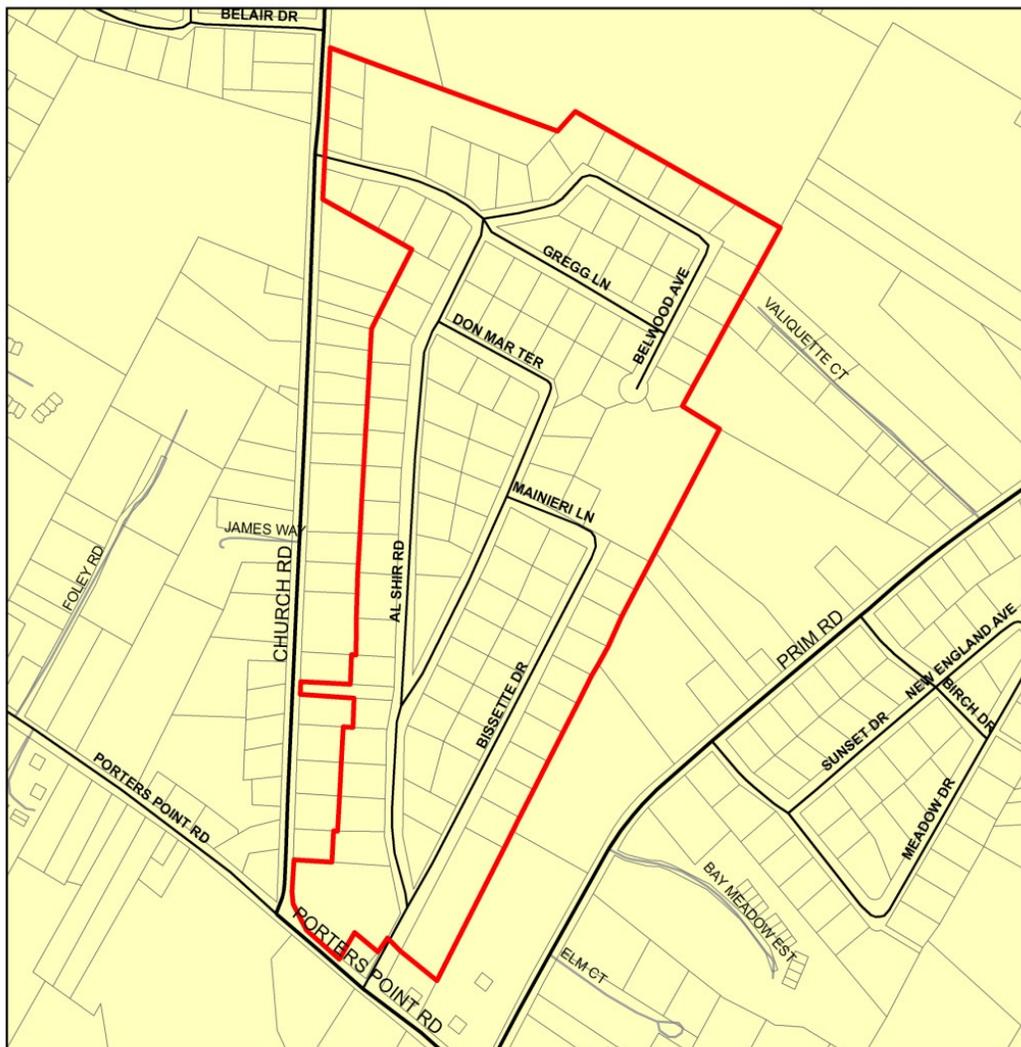
Belwood Study Area

Belwood is an area of land with one hundred eight (108) developed properties located in the Mallets Bay area with access from Porters Point Road and Church Road. The area consists primarily of year-round residences. Detailed wastewater assessments were performed on June 3, 2011 and September 22, 2011.

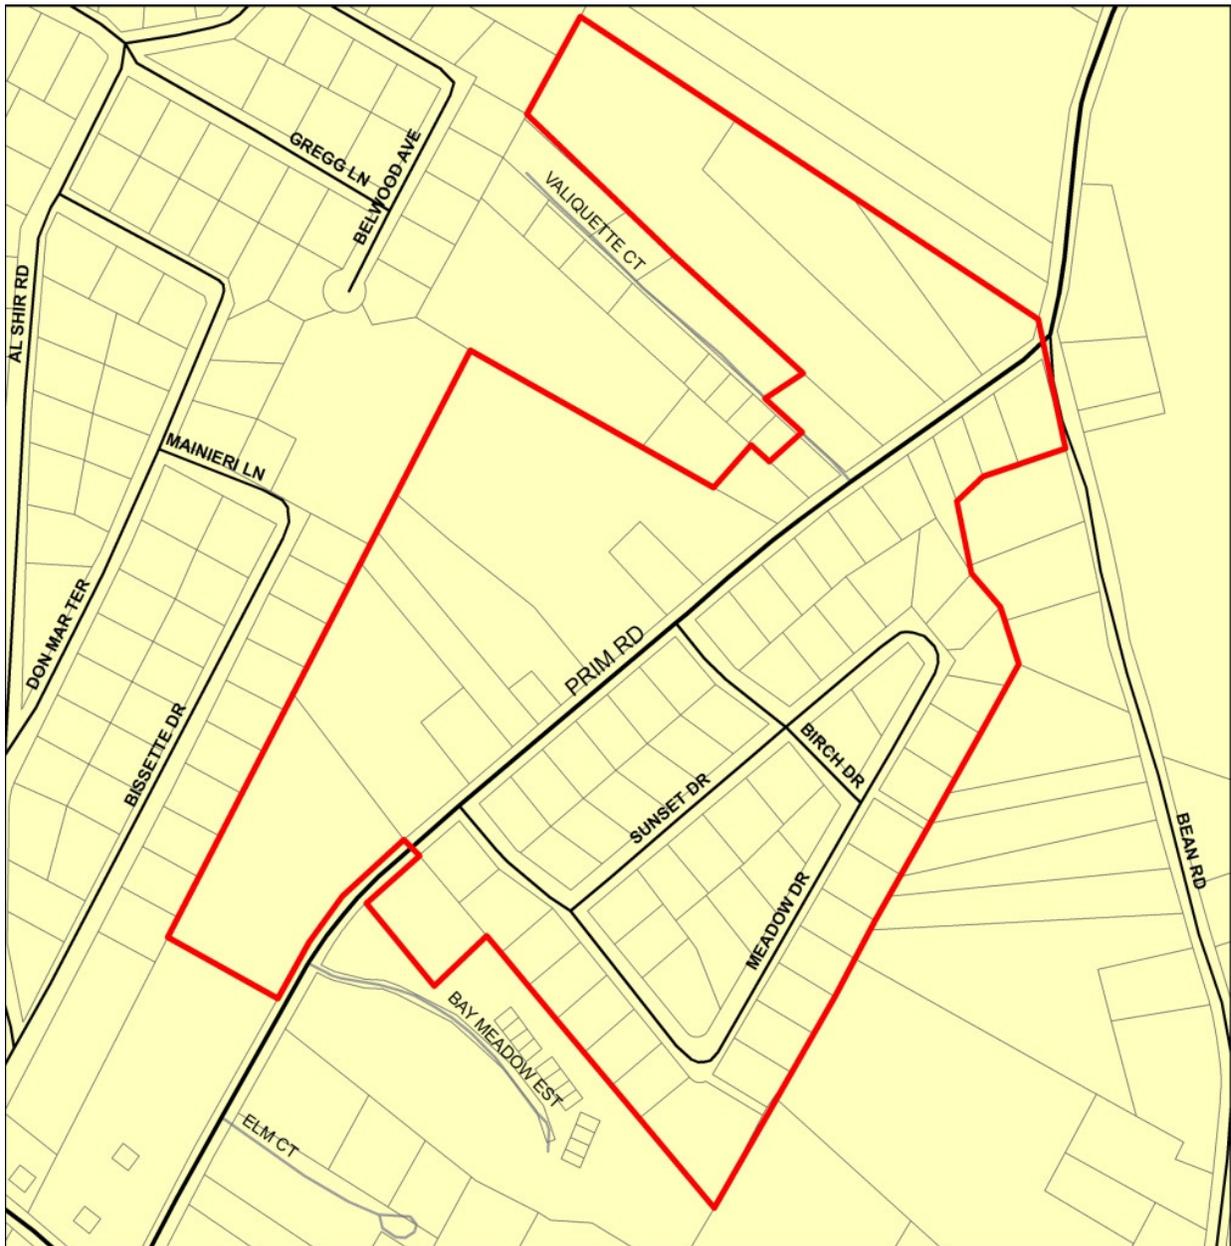
Meadow Drive Study Area

Meadow Drive is an area of land with seventy-five (75) developed properties located in the Mallets Bay area with access from Prim Road. The area consists primarily of year-round residences. Detailed wastewater assessments were performed in this area on December 1, 2010 and September 22, 2011.
