4. ASSESSMENT FINDINGS

4.1. Inner Mallets Bay

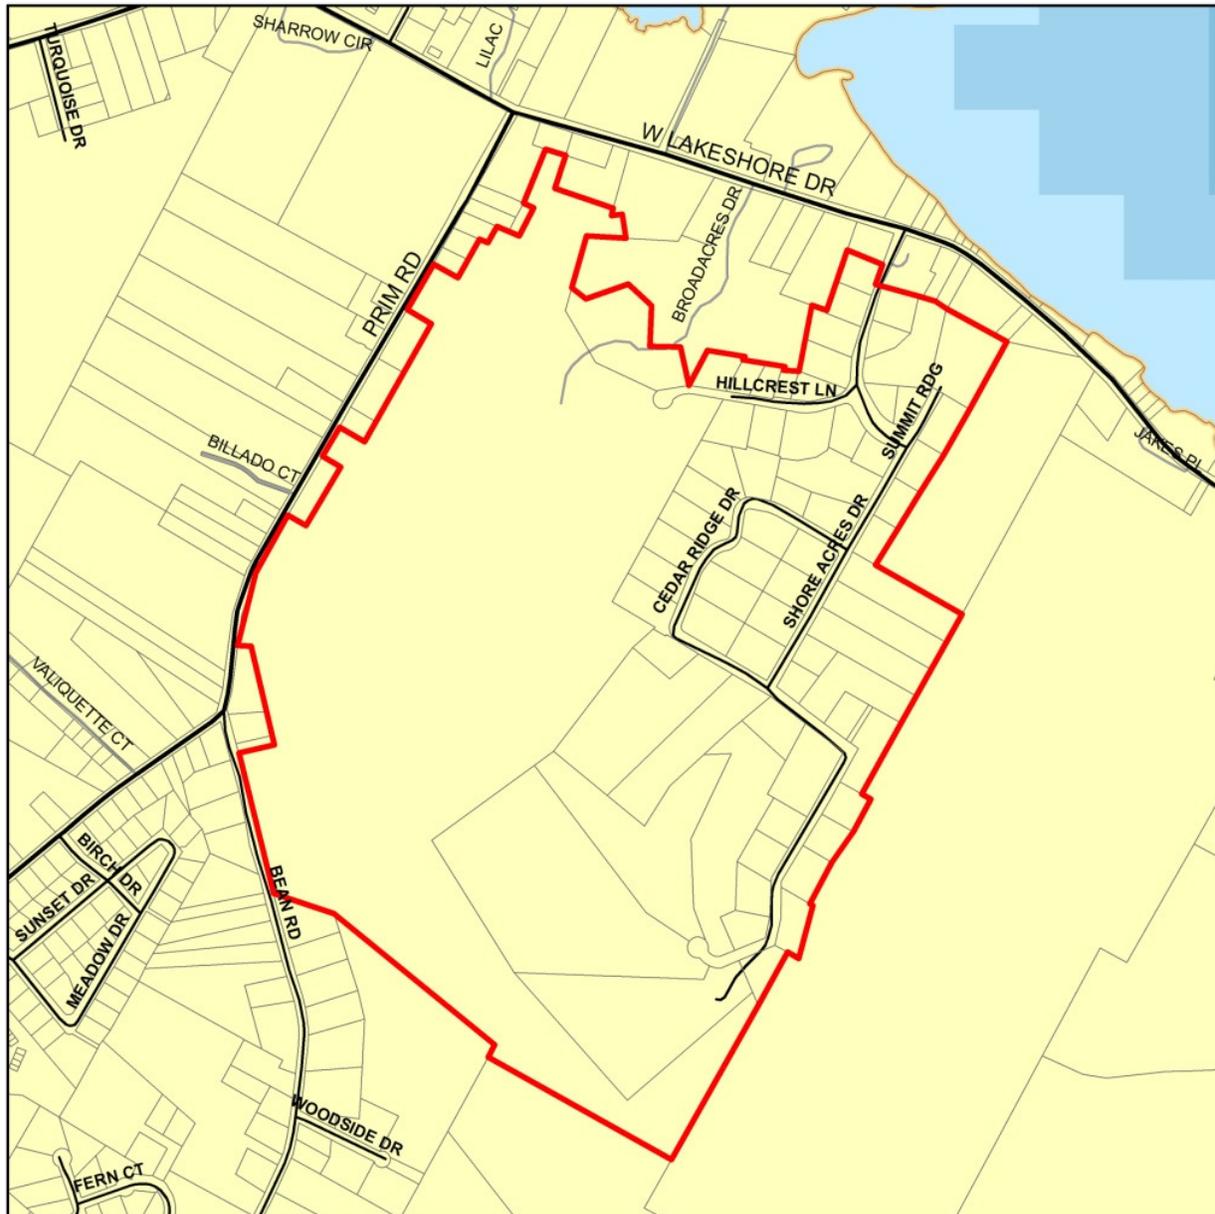
Shore Acres Study Area

Shore Acres is an area with sixty-eight (68) developed properties located in the Mallets Bay area with access from West Lakeshore Drive. The area is primarily year-round residences. Detailed wastewater assessments were performed in this area on November 30, 2010, December 1, 2010 and September 20, 2011.

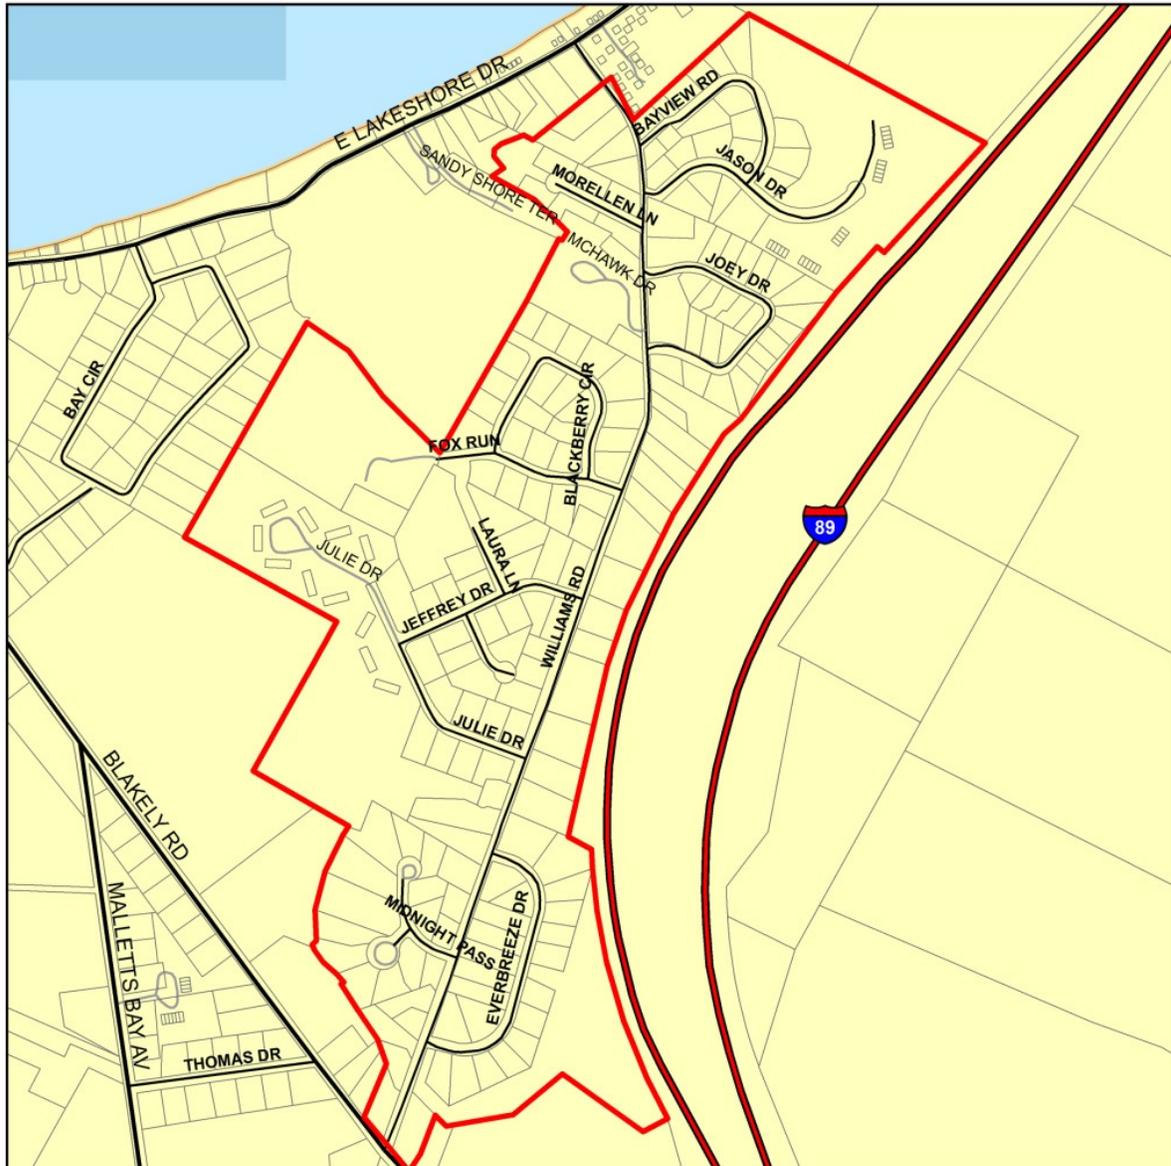
Williams Road Study Area

Williams Road is an area with two hundred ten (210) developed properties located in the Malletts Bay area and is bordered by Interstate 89 to the east, East Lakeshore Drive to the north and west, and Blakely Road to the south. It is primarily year-round residences. Detailed wastewater assessments were performed in this area on June 6, 2011 and September 8, 9, and 22, 2011.

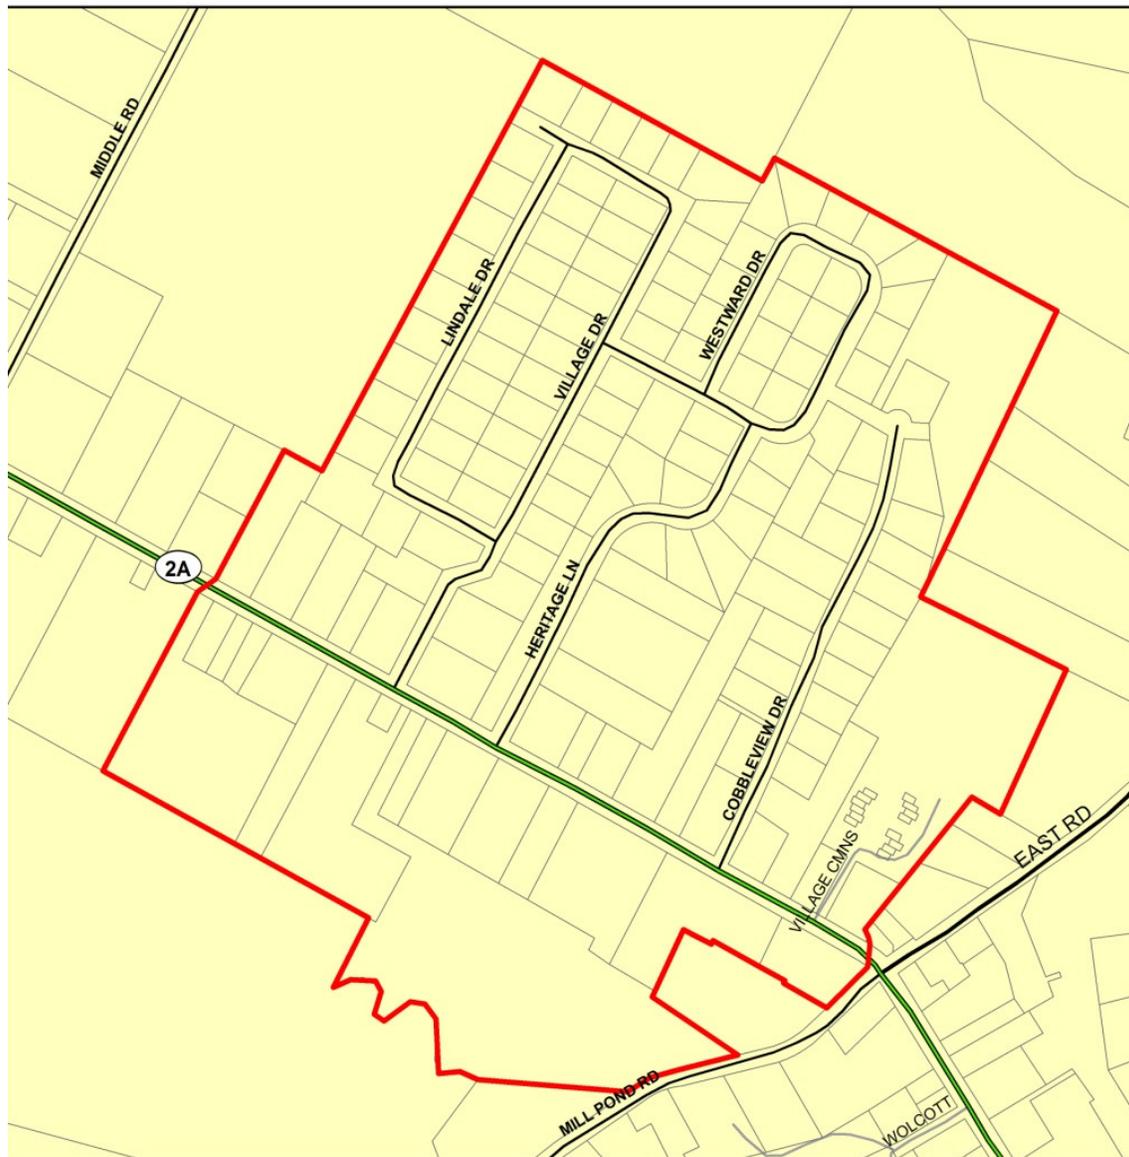
Village Drive Study Area

Village Drive is an area of land with one hundred forty-eight (148) developed properties located in Colchester Village, with access from VT Route 2A. Detailed wastewater assessments were performed in this area on June 15, 2011.

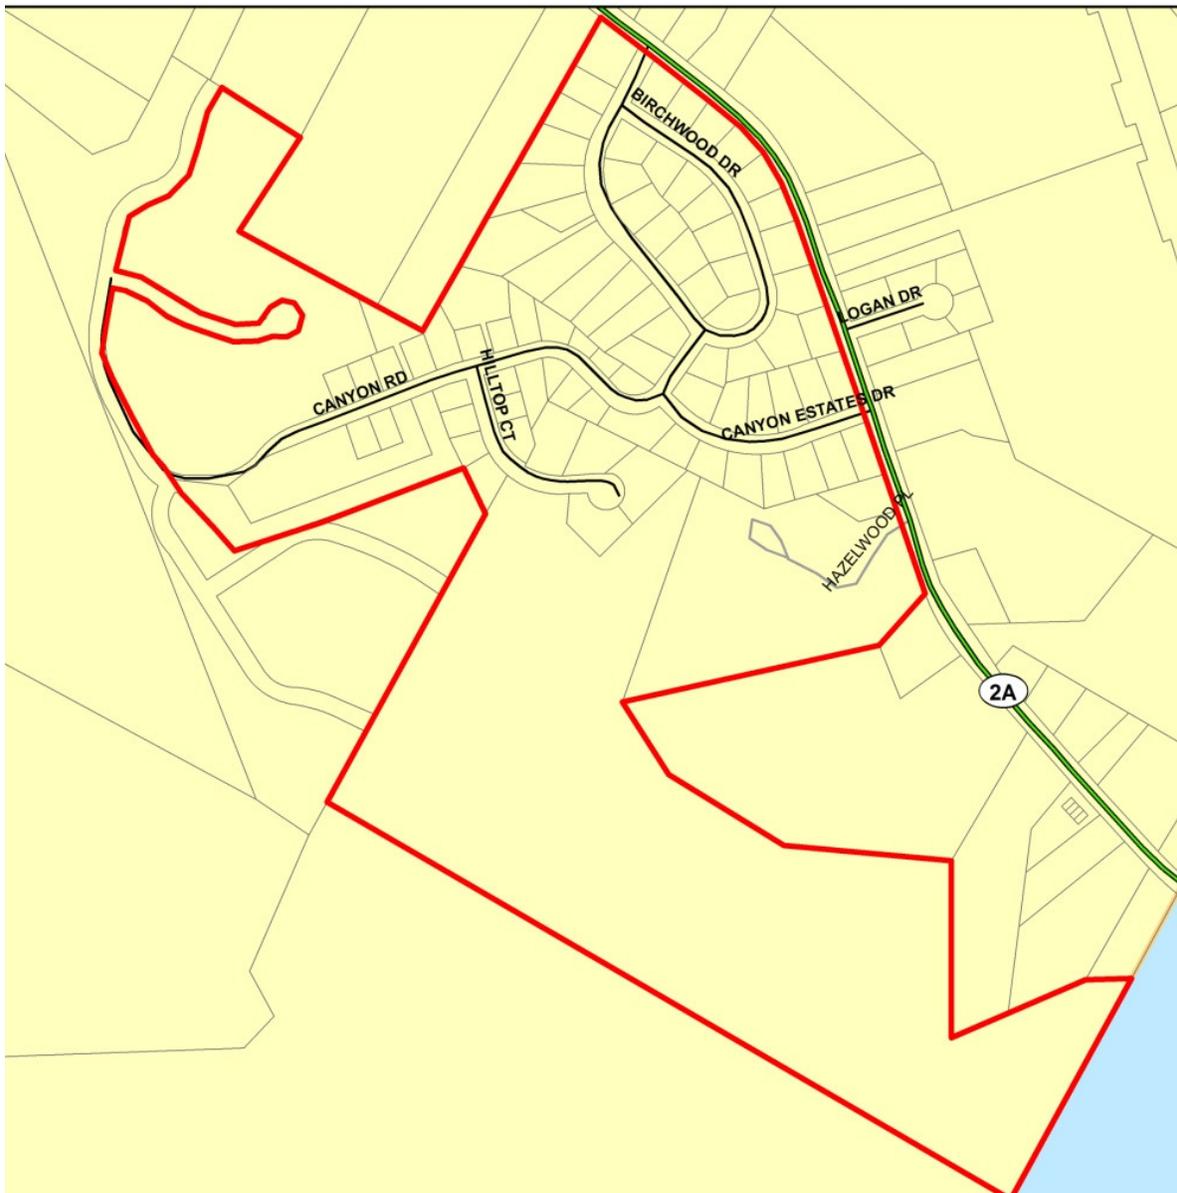
Canyon Estates Study Area

Canyon Estates is an area of land with eighty-two (82) properties located in Colchester village with access from VT Route 2A. Detailed wastewater assessments were performed in this area on December 3, 2010.

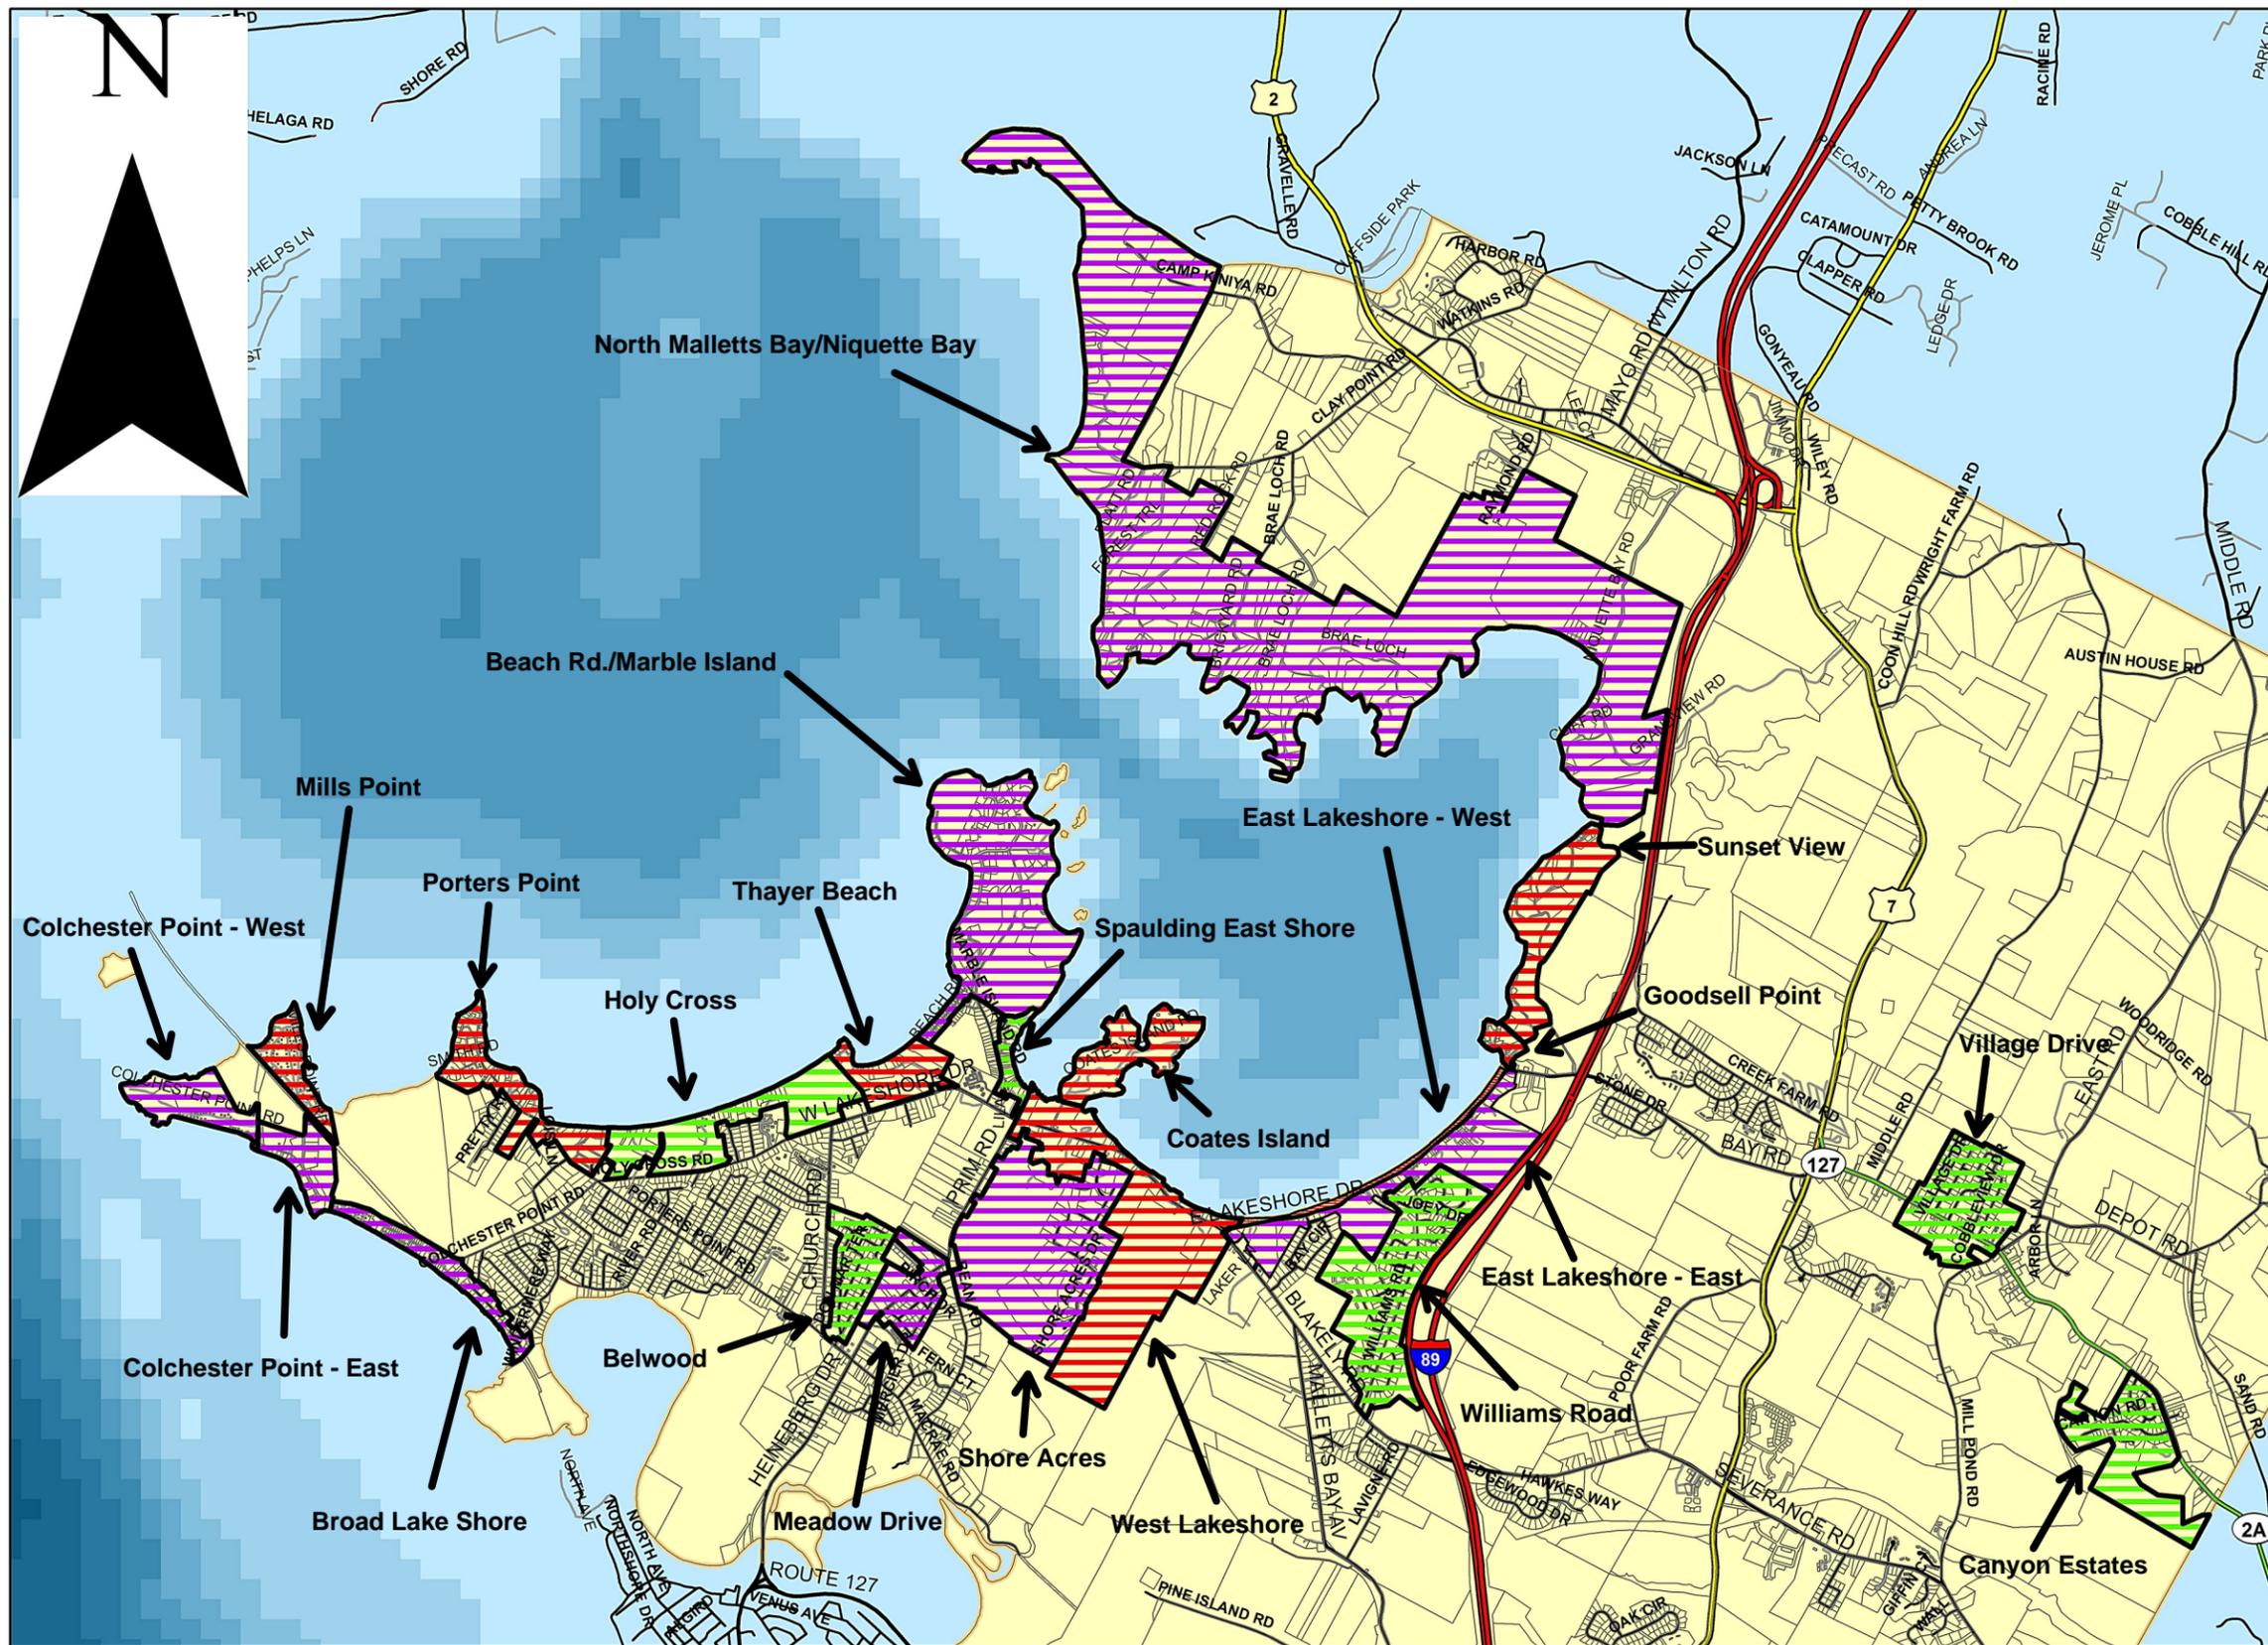
Figure 3 geographically shows each study area with their overall assessment rating for comparative purposes.
